**Stage 4 Excavations and Archaeological Monitoring:
Don Valley Brick Works, City of Toronto**

FINAL REPORT

Archaeological Licence P049 (Steiss)
MCL CIF P049-384-2009, P049-511-2010
ASI File 09SP-13

January 2011

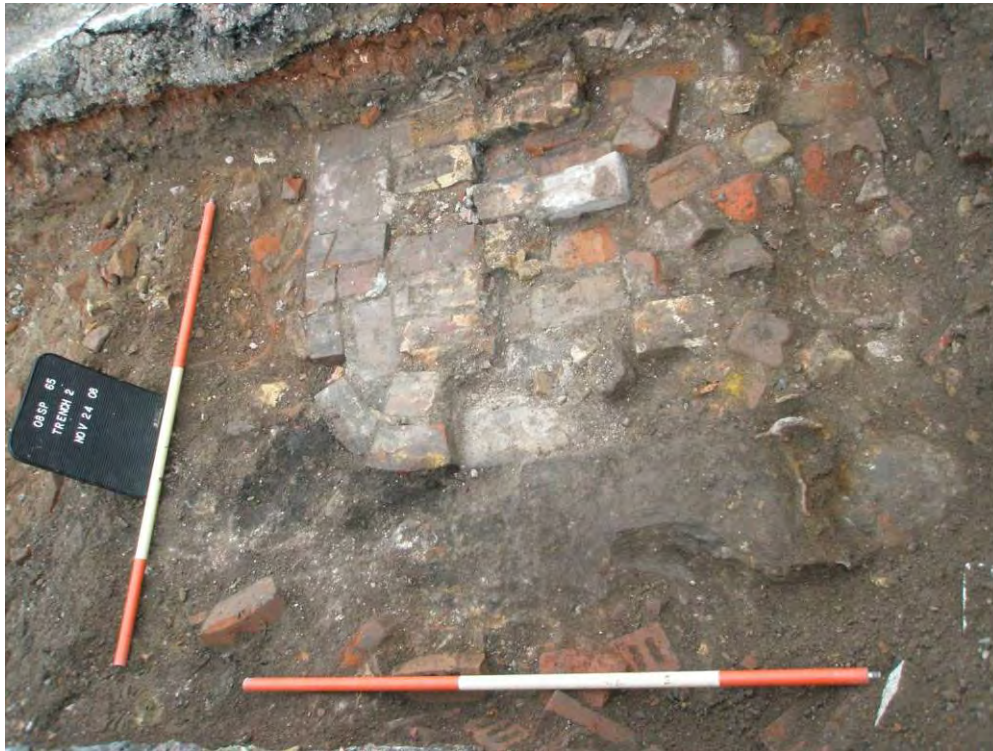
Plate 2: Kiln 3, viewed from the south.

The bricks used in the construction of Kiln 3 typically measured 8½" in length, 4¼" in width and 2½" in thickness (21x11x6 cm) and were frogless. None of the bricks exposed bore any maker's marks. The debris from the flue was not removed to any great depth, but it was noted that a two wythe Flemish bond brick wall had been built across the flue and extended under the floor surfaces.

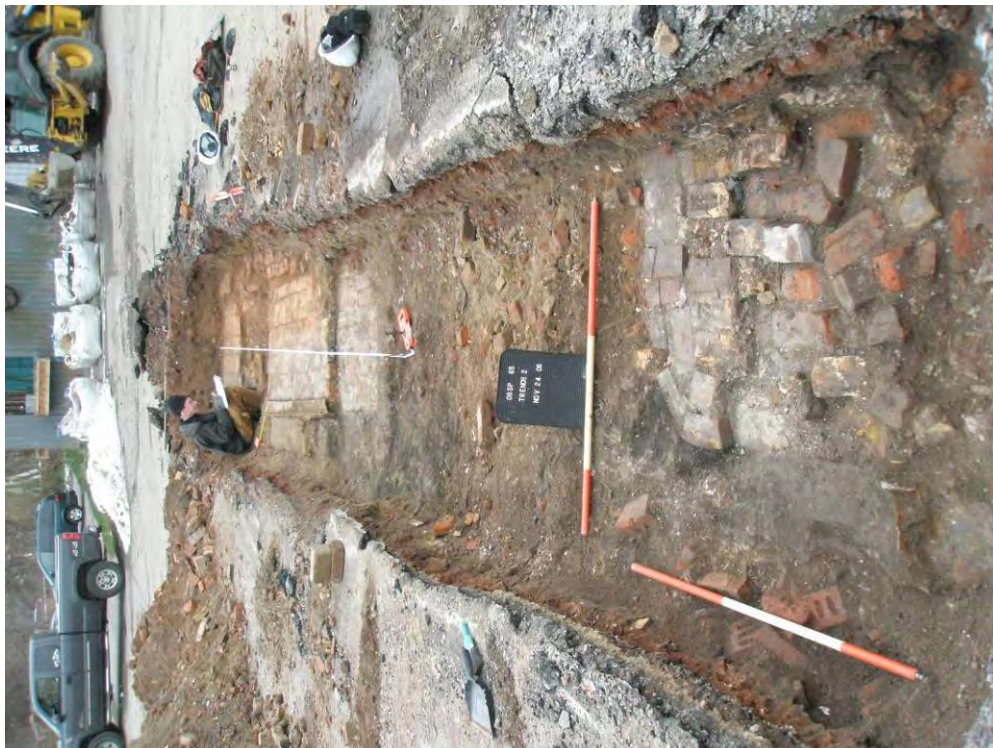
Plate 1: Trench 2 with Kiln 4 (foreground) and Kiln 3 (background), following exposure, viewed from the west.

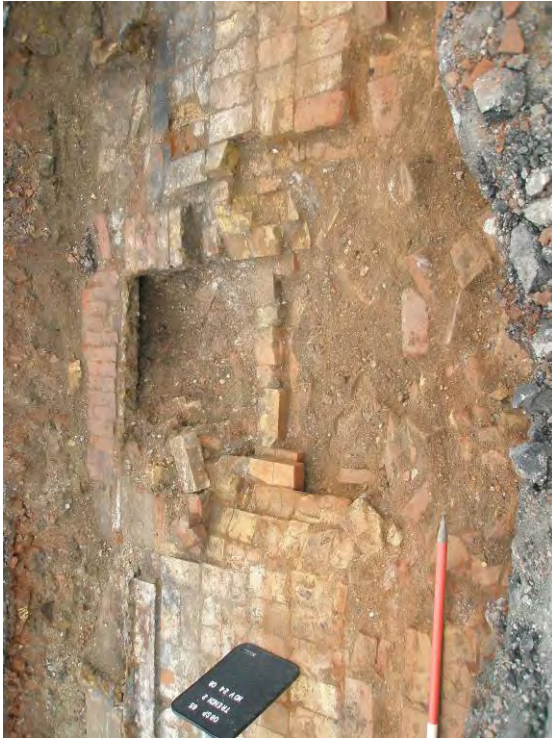
Plate 4: The flue of Kiln 4 viewed from the south.

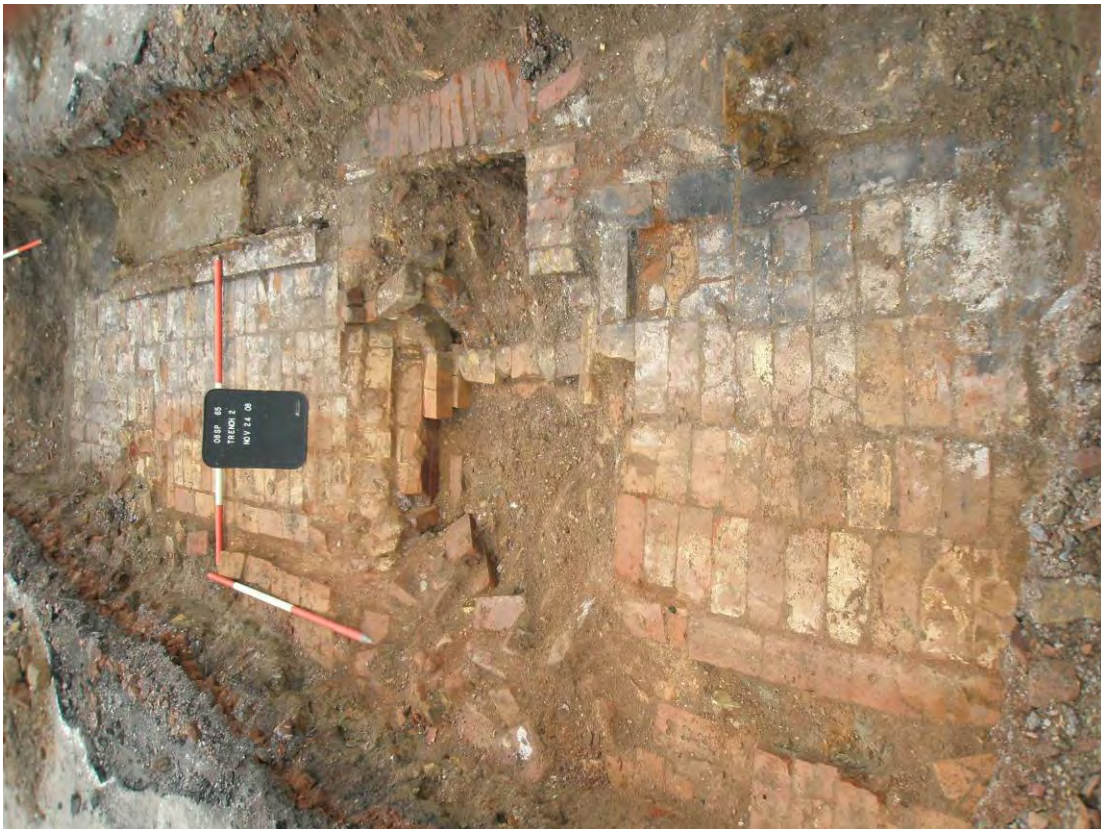
Plate 3: Kiln 4 following exposure, viewed from the west.

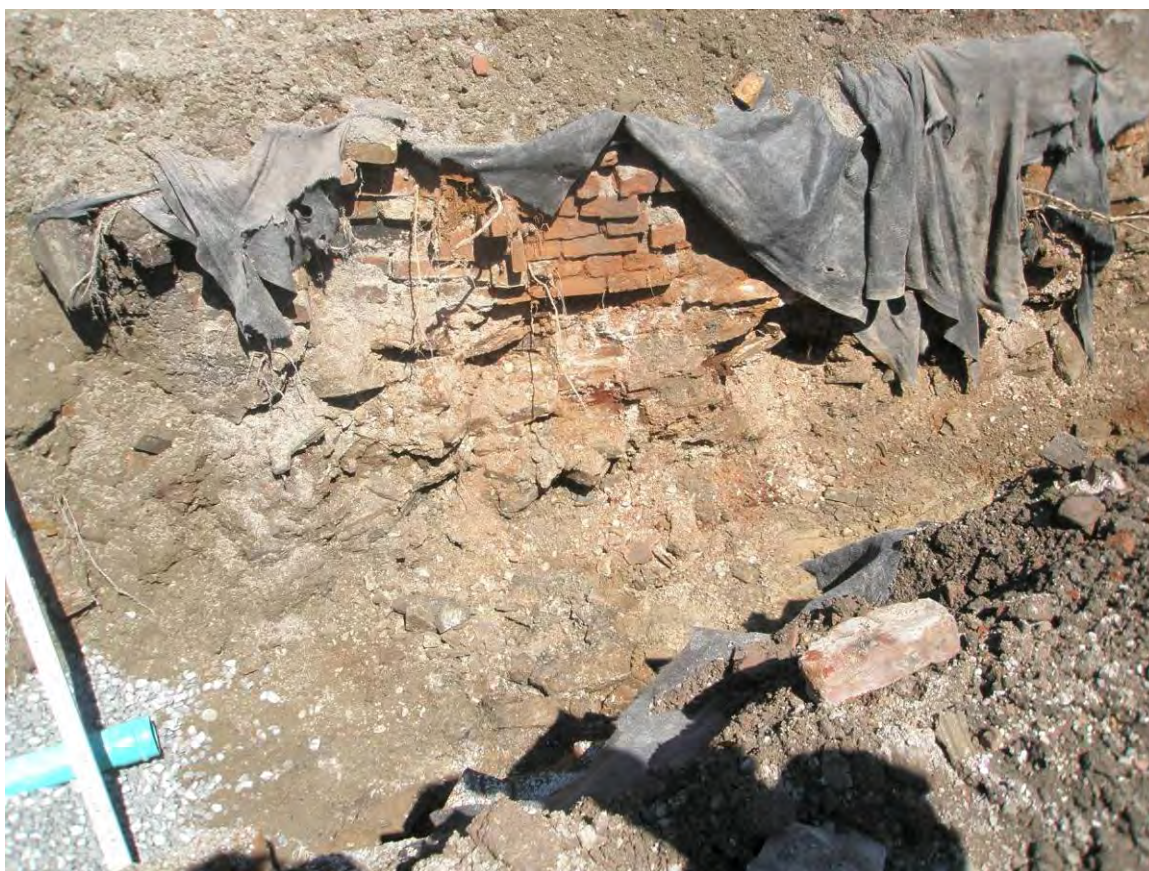
Kiln 6 was set on a six foot wide, three foot high perimeter foundation composed of shale slabs and concrete slab rubble. This structural element was only revealed during the monitoring of the servicing excavations (Plate 8) as the archaeological investigations did not involve dismantling of any parts of the structure. To the inside of the foundation a highly variable mixture of sands, gravels, shale and concrete rubble and coal ash fills formed the substratum on which the kiln base rested.

Plate 8: Exposure of the shale and concrete slab perimeter foundation of Kiln 6 during the service installations carried out after the Stage 4 documentation.

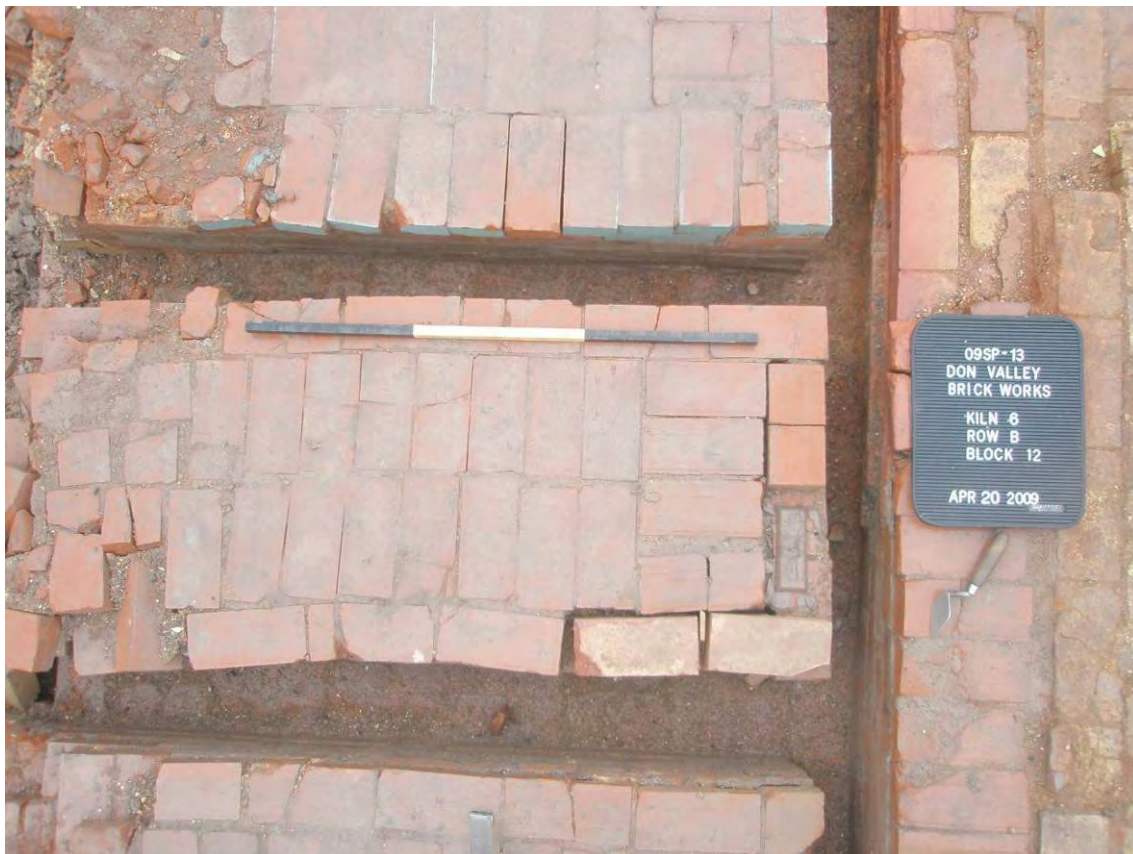
Plate 10: Detail of one of the blocks between the floor channels showing the diverse range of bricks, in this case including enameled specimens, used in the construction/repair of the kiln base.

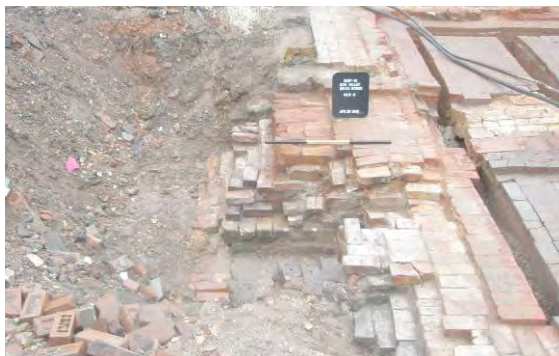
Plate 12: Remains of the possible chimney stack, viewed from the west.

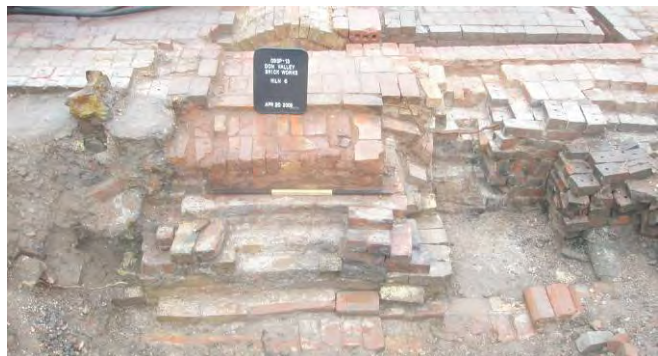
Plate 13: Remains of the possible chimney stack, viewed from the north.

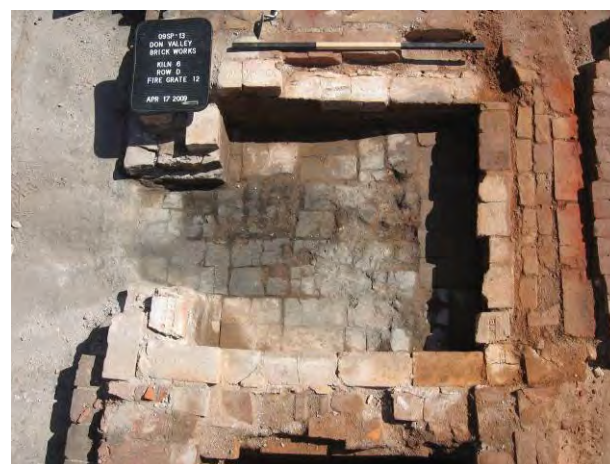
Plate 17: An example of one of the better preserved fire grate floors.

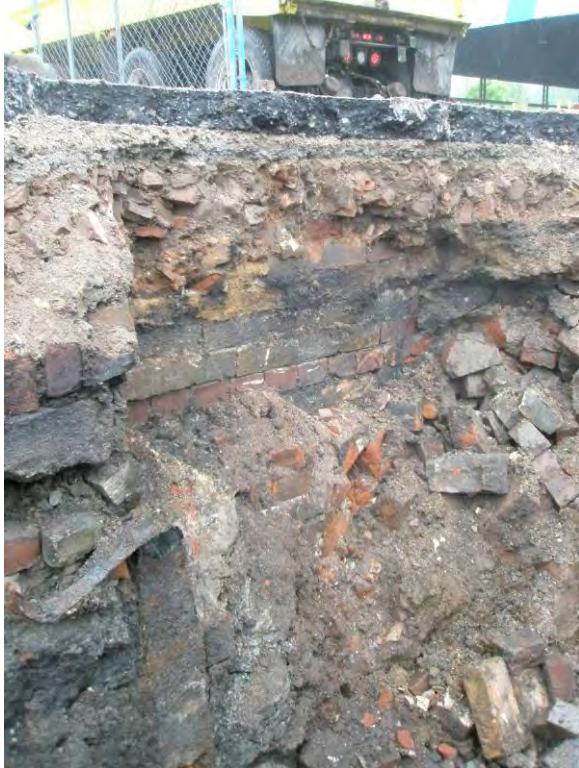
Plate 28: Exposure of the north face of the base of Kiln 5 in the 1500mm watermain trench in the location of Fire Hydrant 5.

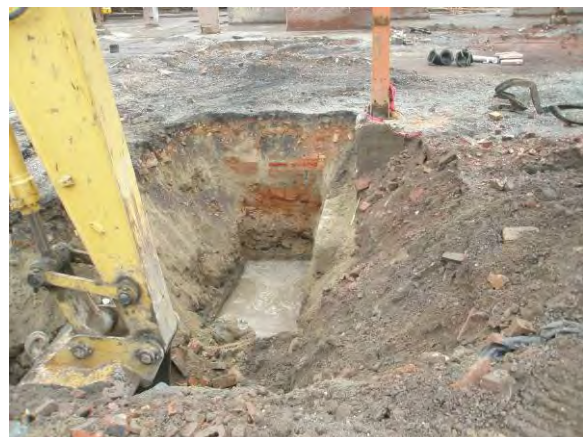
Plate 30: Exposure of the west face of the base of Kiln 7 at the terminus of the 2000mm watermain in Building 14.

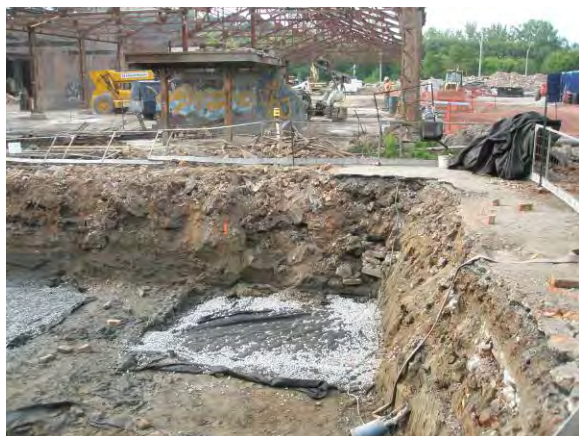
Plate 31: View of the remains of the Building 11B brick walls in the south face of the Pedestrian Bridge excavation area.

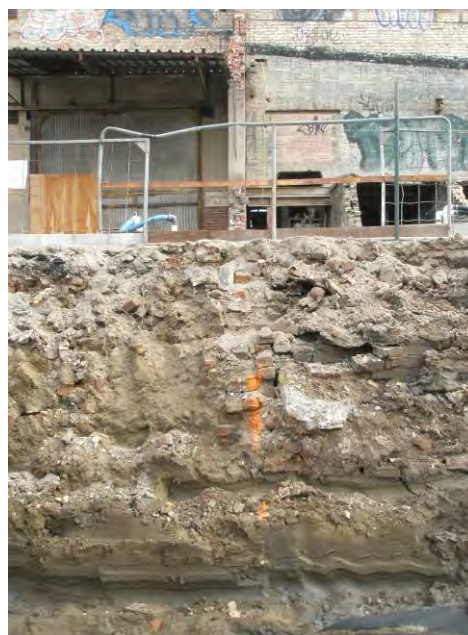
Plate 32: View of the remains of the Building 11B brick walls in the north face of the Pedestrian Bridge excavation area. The surviving portions of these walls are visible in the background.

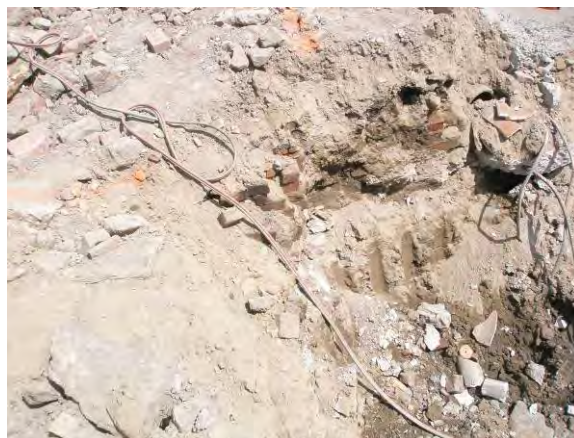
Plate 36: Exposure of a section of brick wall with a return, possibly the exterior wall of the production line building that preceded Building 12.

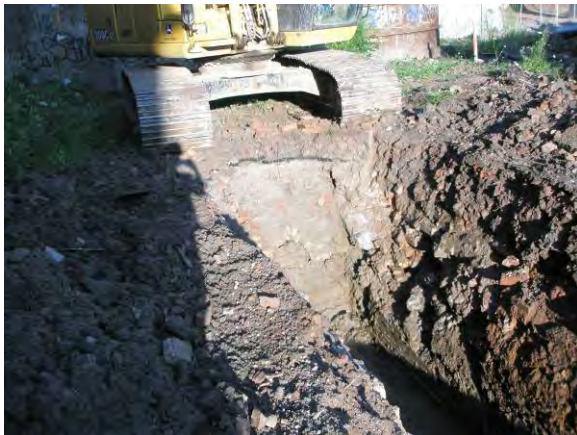
Plate 39: The only intact portion of the east-west flue, seen beyond the west limit of Kiln 11.

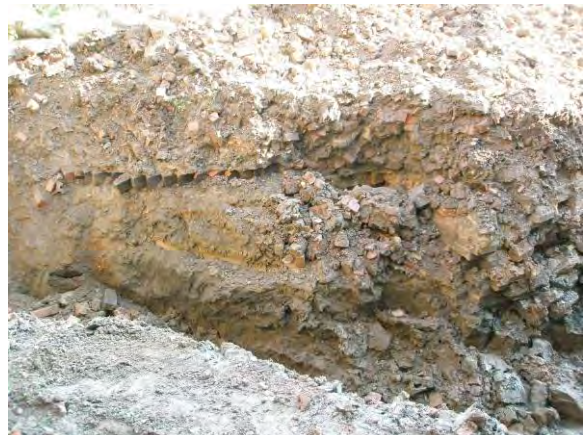
Plate 40: The southwest corner of Kiln 11 following removal of the adjacent section of the concrete apron within the trench. Note the shale footing and the brick paving to the west of the kiln base, which is the same surface as documented during the Stage 2 excavations (Trench 5).

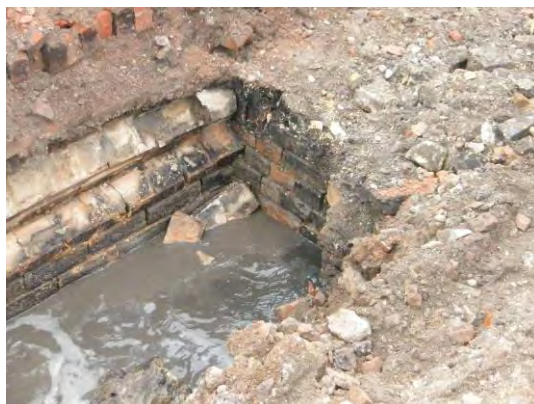
Plate 43: The central flue of Kiln 6. To the right (north) of the brick wall built across the conduit, the flue had been decommissioned at the time of demolition. The wall was then installed to close off this break in the system.

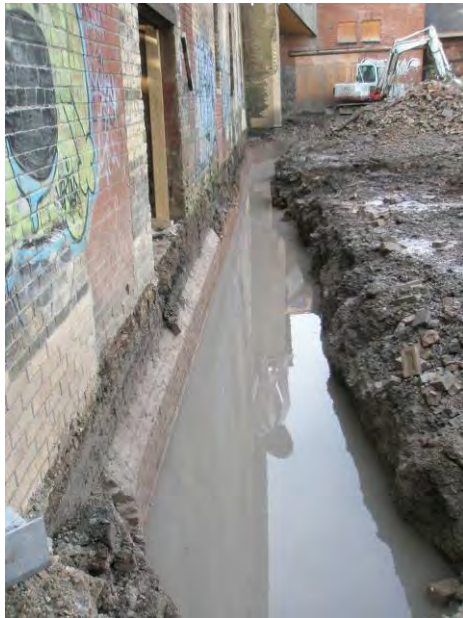
The foundation test pit revealed the presence of an open channel below the concrete apron, immediately adjacent to the Building 11A wall. The apron itself was set on a seemingly haphazard arrangement of steel plates, rails and pieces of metal scrap that had been laid across the top of the channel. The channel was full of water.

Plate 47: View west along the north wall of Building 11A, following the complete exposure of the flue at its base.

The flue at the base of the wall measured 2'6" (0.80 m) in width and at least 3'6" (1.10m) in depth. Sections of the flue walls were built, repaired and rebuilt with all manner of solid, frogged and perforated plain and brushed bricks. The south wall of the flue was battered out slightly from the wall of Building 11A.

It was therefore decided to remove the apron and overlying fills to fully expose the channel along the length of the building in order to determine the most appropriate means of waterproofing and stabilizing the foundation. This work (Figure 2-15 and Figure 12) revealed that the channel was, in fact, a flue that tied into those previously found to service Kilns 9-11 to the immediate north (see Section 4.7). The south wall of the flue and the north foundation of Building 11A were essentially the same structure (Plates 47-49), although the course of the flue swung north away from the building at both its eastern and western ends, such that it appears to have been part of a loop linking the kilns and the “Valley” prior to proceeding west into or through Building 9.

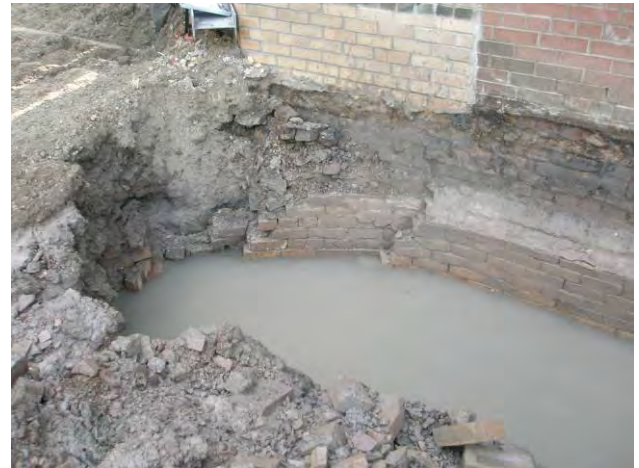
Plate 48: View of the flue at the base of the wall of Building 9 where it begins to turn north to connect to Kiln 9.
