Blacker's Brick Works: A Rare Insight into the Local Manufacture of Bricks in the Latter Part of the Nineteenth Century

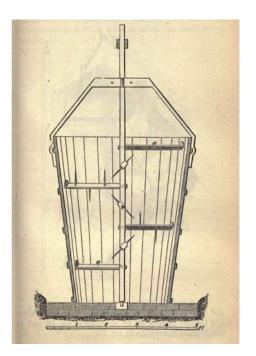
An example of a draughtpowered pug mill typical of a relatively small-scale brick yard (Dobson 1882:Figures 11 and 12).

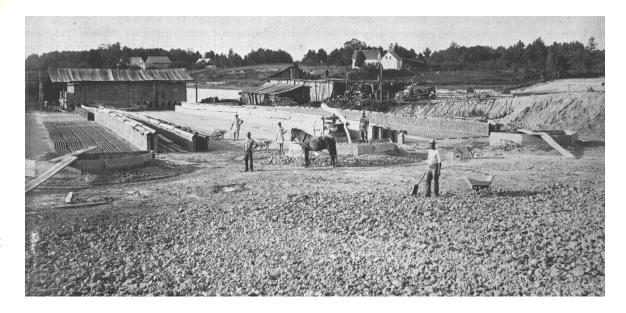
Laying out bricks to dry before haking (Reiss and Leighton 1909:Figure 1).
