**Stage 2 Archaeological Resource Assessment
of the
Proposed Visitor Centre Location
at the
Fort York National Historic Site (AjGu-26)
City of Toronto, Ontario**

Archaeological Licence P102 (Stewart)
MCL CIF#s P102-004-2009; P102-005-2010
ASI File 09SP-37

June 2010

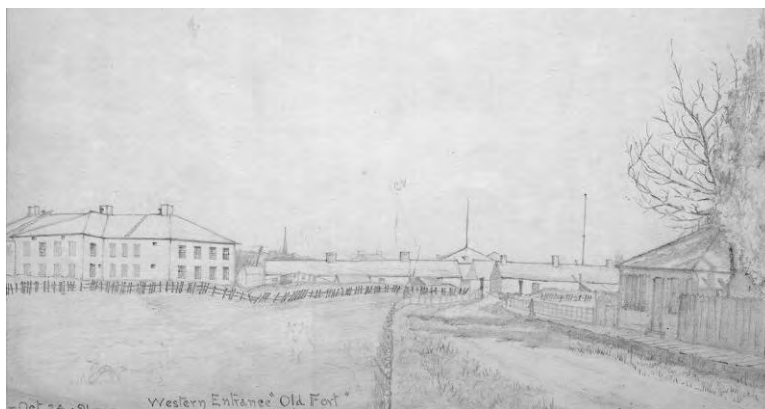
S/1891

A pencil sketch (Plate S/1891) drawn in 1891 shows what appears to be a square single-storey house with a hipped roof on the south side of Garrison Road, with an open field or pasture separating the house from the South Soldiers Barracks in Fort York to the east.

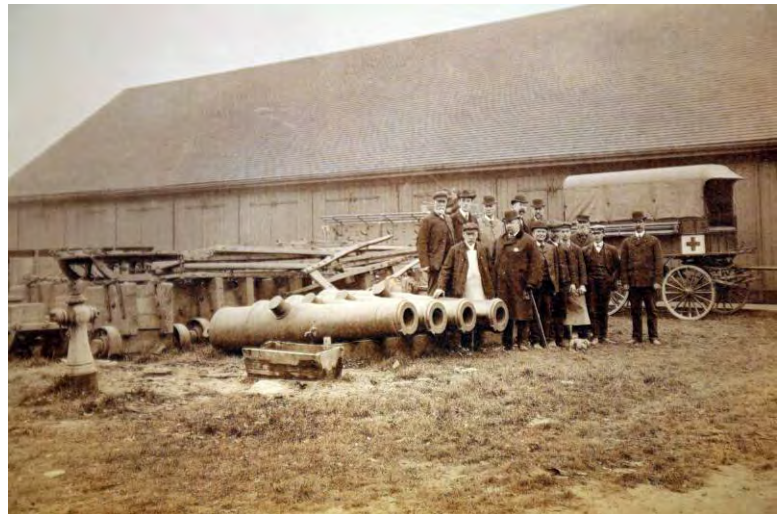
P/1899

An 1899 photograph (P/1899) with a southeasterly view shows part of the Ordnance and Supply Yard and the north wall of the gun carriage shed (#13 Gun Storage building in the insurance document), with eight of its 16 pairs of doors (see above) clearly visible, and the open character of the yard. There is an intermittent ground cover of low grasses or weeds with patches of exposed sediment, though the nature of the unvegetated surface is not clear (the importance of this question relates to Lot 43, an engineered surface defined during the archaeological excavations). A fire hydrant is visible in the left foreground, attesting to installation of water infrastructure across the site by this time.

South side of yard: a single building “[#] 4 Gun carriage shed” extends parallel to Garrison Road, enclosed by a fence/stockade. This building is probably identified in a later fire insurance document (D/1933) as “#13 Gun Storage...Wooden structure same as #12 [which is “panelled with rough lumber 12” wide, no foundation set on posts, ready roofing and one brick chimney”] side has 16 prs. of doors 9 ft. wide. Ready roofing and one brick chimney....41 ft.6 in x 160 ft. 6 in.” The east half of the north side of this building is likely depicted in P/1899.

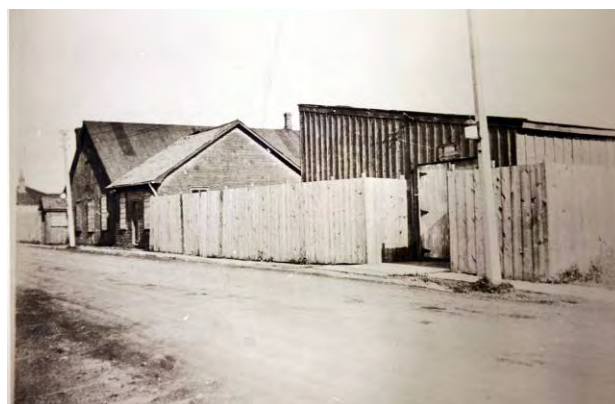
P/1926

To the west, a new building (about 40 x 25 ft) had been built on the south edge of Garrison Road. This building appears to be shown in right foreground of P/1926.

Lot 41, Unit 500-200. Lot 41 contained eight refined white earthenware ceramics and 18 non-ceramic artifacts, including one smoking pipe and seven pieces of faunal bone. Four wire nails were also recovered, and may be explained by the proximity of Unit 500-200 to a frame building constructed west of the Military Store sometime after World War 1 (Figure 5; Plate P/1926, section 2.0).

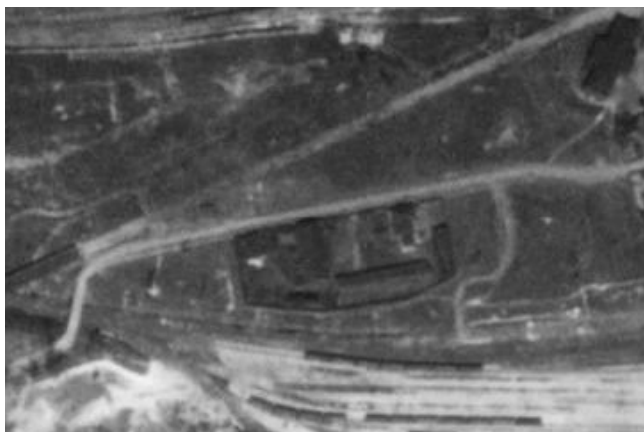
P/1931

An air photo from 1931 (P/1931) shows (indistinctly) light-coloured paths and roads/routes that fragmented much of the Garrison Common, on both sides of Garrison Road. It includes a prominent route extending at a right angle south from Garrison Road, east of the Ordnance complex, returning west towards the south end of the new building.

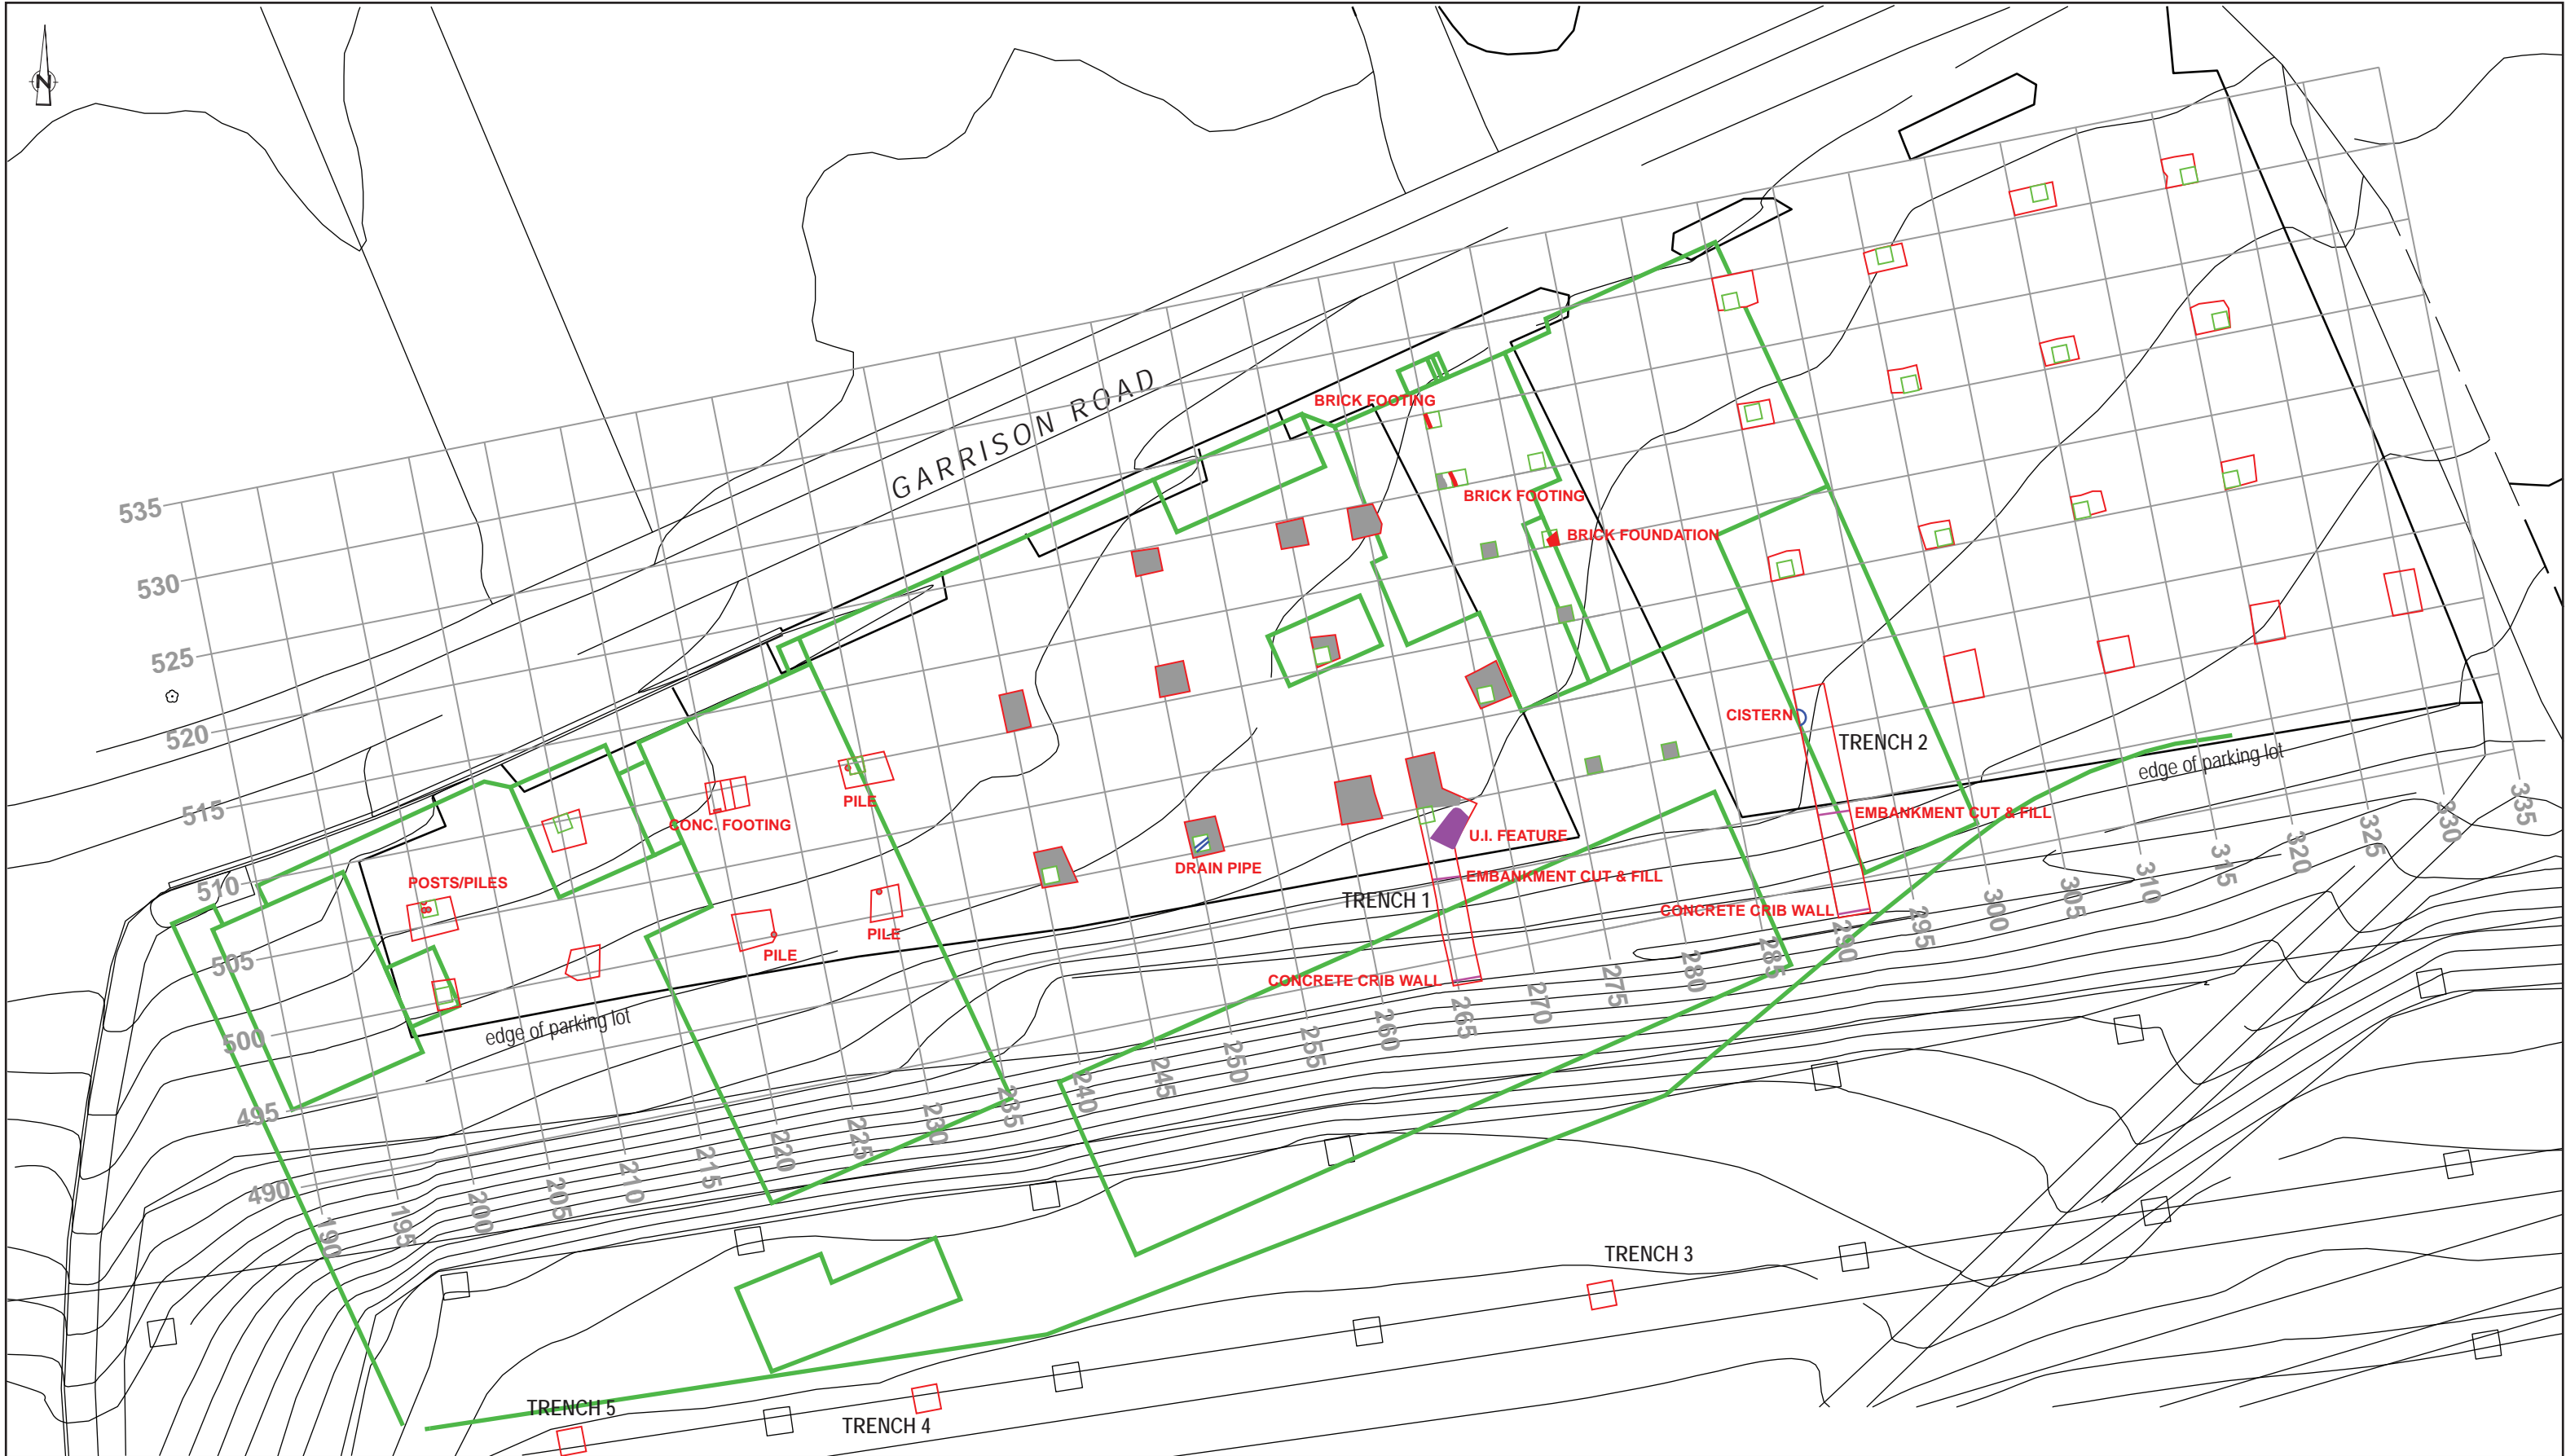
Figure 5 illustrates the locations of all excavation units and trenches, relative to the predicted locations of the former structures within the Ordnance Yard east of the existing entrance from Fort York Blvd. Excavation generally proceeded down through layers of fill and the underlying geological substrate (clay-rich till) to a level from which no artifacts or cultural features were encountered.

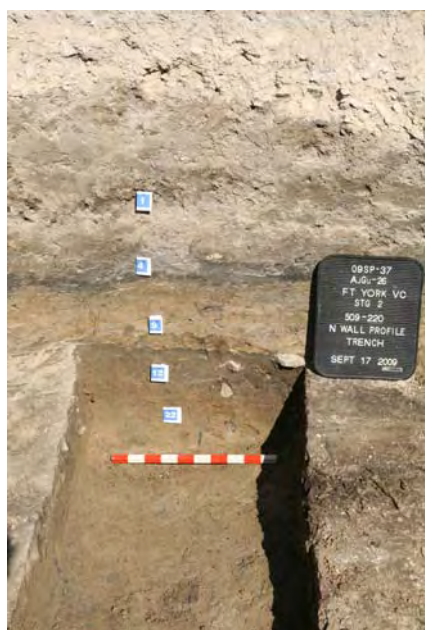
In most of this area, the upper buried soil horizons have been removed, and only the lower part of the soil profile (relatively unweathered clay-rich parent material) survives below the cultural fill deposits. Building piles (Lots 21, 24) for the Military Store were embedded in this substrate and layers of organic fill overlie these features. Exceptionally, a truncated section of the A horizon (Lot 12) survives in Unit 509-220 (Plate 1) and it contains early-to-mid nineteenth-century ceramics, faunal bone, smoking pipe fragments and some twentieth-century wire nails (Appendix C) that may have been introduced to the early midden through renovations to the building, as evidenced by a concrete footing and possible remnants of a wooden floor (Lots 35, 37). These lots have been capped by layers of fill that appear to have weathered in place, suggesting that two successive fill layers constituted two ground surfaces lasting decades.

Plate 1: Stratigraphic sequence in north wall of Unit 509-220, with original surface of the Garrison Common (Lot 12) capped by fills.

Construction of the Military Store preserved the former Garrison Common ground surface (Lot 12, buried A horizon). A mix of mid-nineteenth century ceramics and twentieth-century wire nails was recovered from a 50 cm wide test trench hand excavated to sample Lot 12 (see also Plate 1).

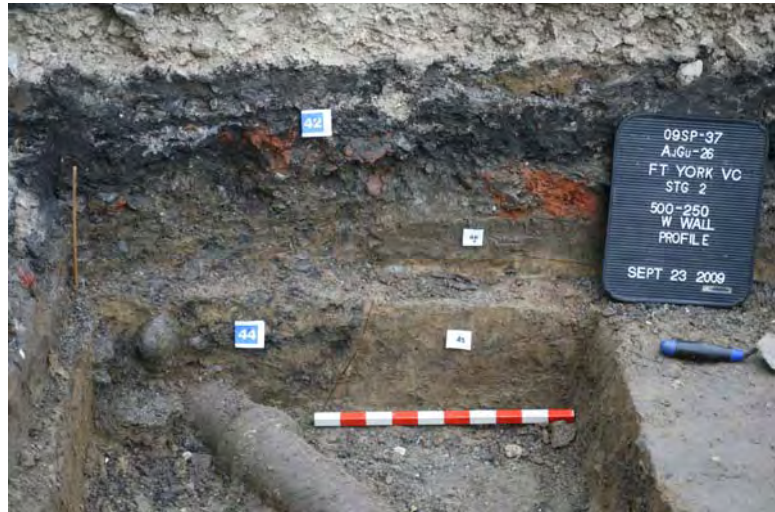
Plate 2: Pipe trench (Lot 44) excavated through original ground surface (Lot 46) and the clay substrate (Lot 45).

Lot 44 is located within the Ordnance and Supply Yard, underneath the engineered pavement (Lot 43) in Unit 500-250, and is oriented roughly east-west and thus may have serviced the Military Stores Office. A domed, two-piece tunic button of the Royal Artillery was found in the trench of Lot 44 (Cat.# 291), and its design is dated to the period 1855-1873, indicating the button was probably lost when the pipe was laid circa 1868.

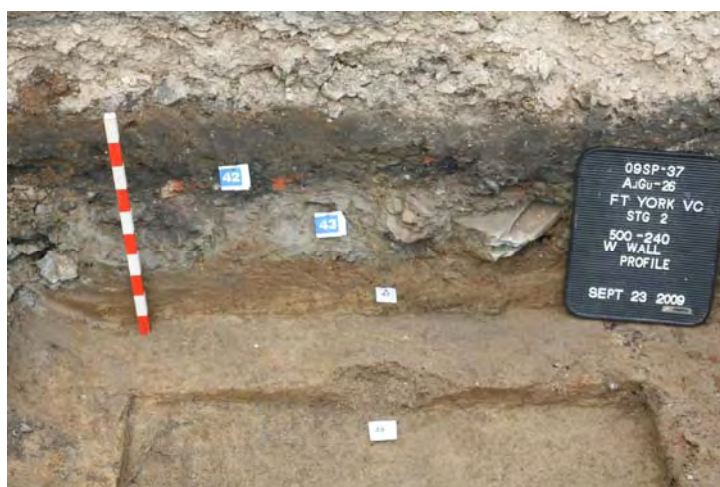
Plate 3: West wall profile of Unit 500-240 after Lot 43 removed. Shale slabs are sitting on top of the former surface of Garrison Common (Lot 47).

The early-to-mid nineteenth-century landscape of the Garrison Common is best preserved under the engineered pavement (Lot 43) associated with the operation of the Ordnance and Supply Yard, another feature that will be described below. Excavation below Lot 43 in four units (500-240, 500-250, 505-270, and 510-260) revealed the presence of a buried organic soil horizon (Lots 46 and 47) that contained brick, ceramics, glass, metal, bone, mortar, cinder/slag and shoe leather (Plate 3). This buried organic soil horizon is interpreted as the surface of the ground (an A horizon or topsoil) that existed before pavement was laid down in the 1860s. It is assumed that the buried soil is likely preserved across the entire area underneath the pavement.

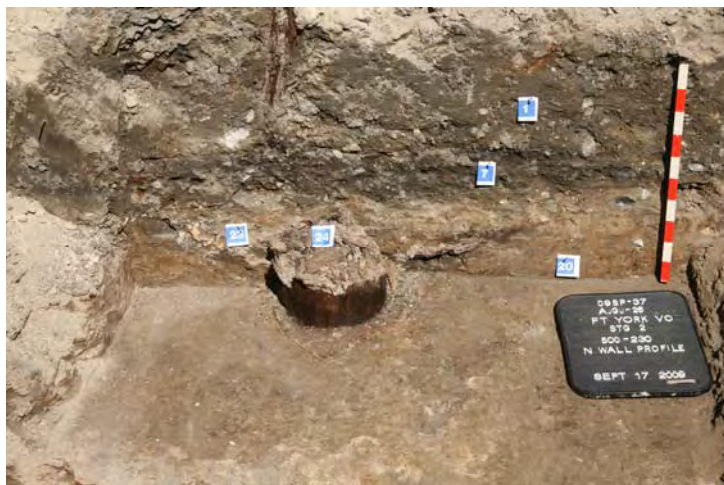
Plate 4: One of the wooden piles (Lot 24) for the Military Store building. Note absence of A Horizon below the fill on north profile of Unit 500-220.

Two 10" diameter wooden building piles (Lot 24; Plate 4) were uncovered 7.3 m (24 feet) apart along a line oriented 80 degrees east of grid north (Figure 5). These piles, a wooden post observed in profile in the southeast corner of Unit 500-220 after the east wall of this unit partly collapsed after a heavy rain, and a post hole (Lot 21; Plate 5) from which a pile of similar diameter likely had been removed appear to be part of the east wall of the Military Store building (Figure 5). The post hole and pile that occur along the 229E line are eight metres (26 feet) apart.

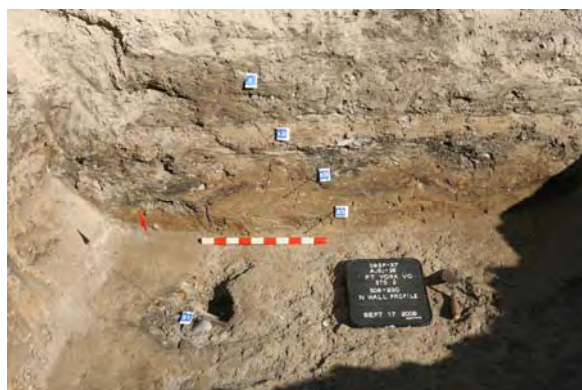
Plate 5: Post hole (Lot 21) on 229E grid line in alignment for Military Store building. Note presence of undulating A Horizon (Lot 19) on west profile of Unit 509-230.

In unit 509-230 where the post hole occurs, a highly convoluted layer (Lot 19) with organics (Plate 5) may represent a buried, rutted A horizon – the ground surface of Garrison Common at the time the building was constructed. No indication of a buried A horizon was, however, observed in either of the other units containing piles.

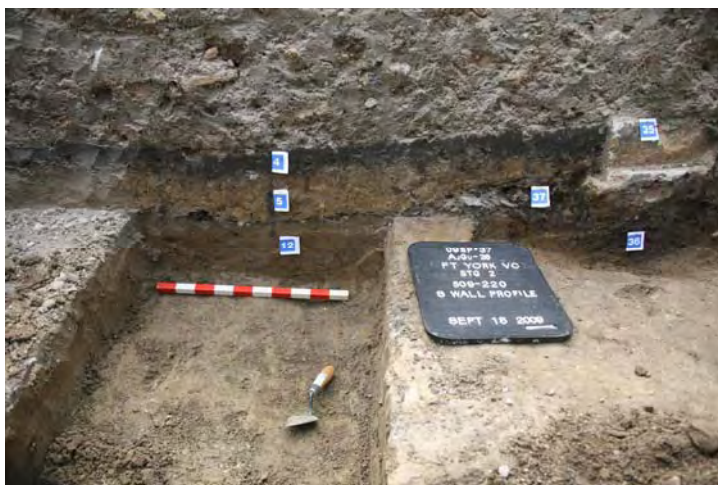
A 30 cm wide concrete footing (Lot 35) with an irregular conformation to the underlying pit (Lot 36), suggesting that it was poured into a form with no base, was observed in the south wall of Unit 509-220 (Plate 6). One end of a decayed wooden plank (Lot 37) rests on a sill of this footing and may represent an interior floor. The feature appears to be part of the Military Store building (Figure 5), and may represent part of an addition, circa 1935, to the northwest part of the building.

Plate 6: South wall profile of Unit 509-220 with concrete footing (Lot 35) in pit (Lot 36) on extreme right of photo and test trench in Lot 12 in foreground.

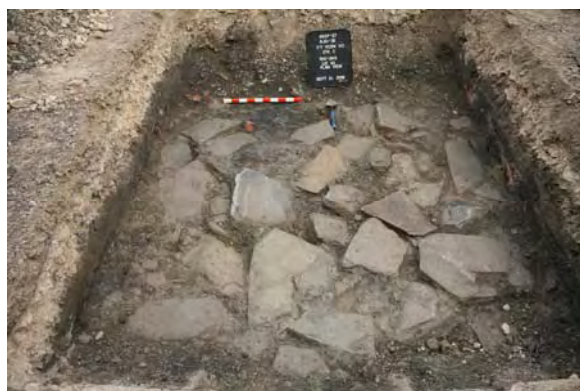
Plate 7: Engineered surface (Lot 43) as it was first revealed in Unit 500-240.

engineered pavement, comprised of split shale boulders and cobble spalls covered and packed with a layer of gravel (rounded beach pebbles). This feature is primarily captured by Lot 43 and possibly 79 but part of the gravel surface appears in Lots 42, 48 and 63. Coal ash also may be associated with this engineered pavement as it is a major component in contexts (Lots 42, 48, 63, 73) that overlie the boulders. Section 4.5 provides further discussion and photographs of Lot 43.

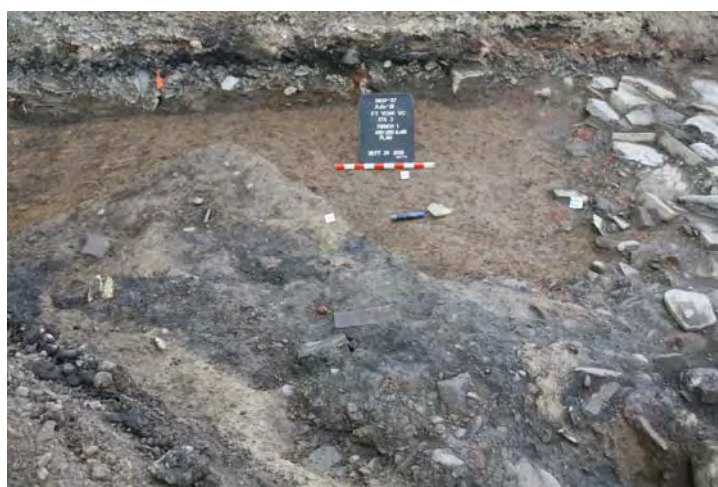
Trench 1 contained a rectangular pit feature (Lot 51) cut into the buried A horizon (Lot 47) just south of the south edge of the engineered surface (Lot 43) (Figure 12, Plate 10). In plan, approximately 2 m long by 1 m wide of the feature was visible. A 50 cm wide trench was excavated through its mid-section to sample its contents but it could not be completed as Lot 51 continued to extend beyond the east edge of Trench 1. The fill, which contained demolition debris including several cut stone blocks and brick, extended to a depth of 60 cm, and the pit possessed a rounded, basin profile.

Plate 10: Looking west over rectangular pit feature (Lot 51) exposed in Trench 1.

The precise function of this feature could not be identified. Its location is, however, close to (albeit north of) the predicted location of the gun carriage shed that formed the south edge of the Ordnance and Supply Yard, and no other buildings were illustrated historically in that location (Figure 5). A cut block of stone similar to those in Lot 51 was observed in profile in the west wall of Trench 1 at 499-265 within the engineered pavement in Lot 43 (Plate 10; visible in the wall to the right of sign board). It is possible the pit functioned as a storage cellar within the gun shed.

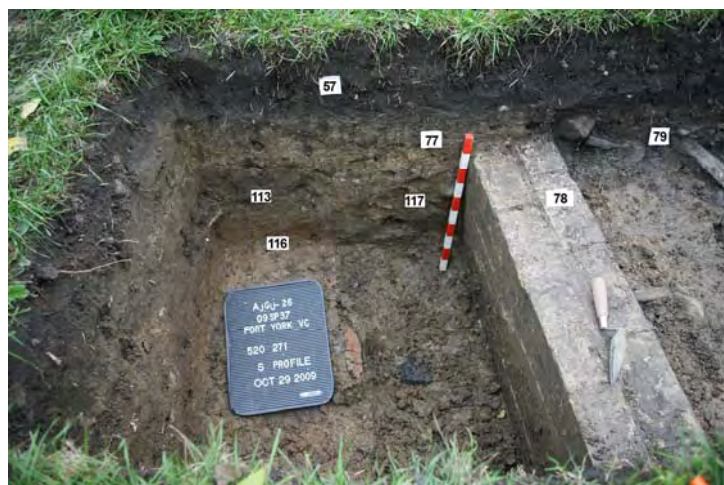
Plate 11: Looking south over brick footing (Lot 78) and the builder's trench (Lot 117) for the Military Store Office.

The footing extends parallel to the predicted orientation of the military store office [known later as the #11 House (D/1933)] located on the east side of the Ordnance and Supply Yard. This building was listed on the 1933 fire insurance document as a single storey frame structure on brick and stone foundations, with outer dimensions of 41' x 65' and Manitoba siding, a type of metal sheeting designed for use on large buildings where uneven settling of the building frame may cause problems with the fasteners used with the siding (The Metallic Roofing Company of Canada Ltd. 1890:9).

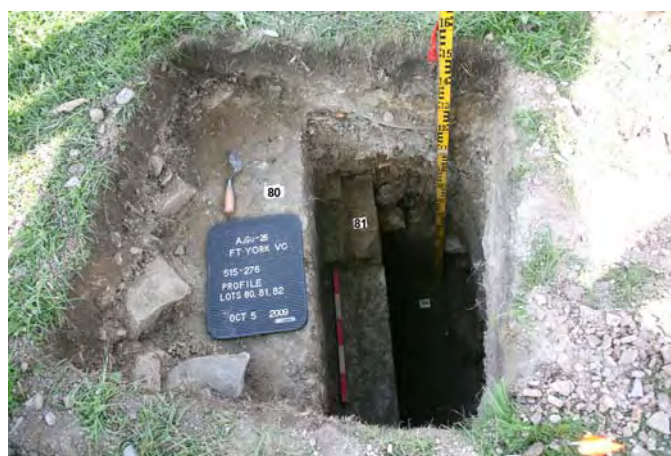
A brick wall (Lot 81), identical in material, orientation and construction to that designated Lot 78 was found in Unit 515-276 (Figure 14; Plate 12). The elevation of the top of the wall is 81.60 m asl (70 cm below local ground surface). The top of the wall remnant is uneven as the demolition process involved variable removal of the upper courses. The elevation of the lowermost course of brick exposed, which lies at the same level as a concrete floor, is 80.85 m asl. The wall survives to a height of 80 cm, representing 11

Plate 12: Looking north over brick wall remnant (Lot 81) and basement adjacent to engineered pavement (Lot 43).

It is assumed that this wall is part of an exterior foundation as the west half of Unit 515-276 contained Lot 43, the engineered pavement documented directly to the west of the Military Store Office noted above, and its location corresponds with the projected location of the office building. The basement, however, may only be partial, corresponding to a rear addition made to the building sometime between the publication of the 1871 and 1909 maps of the military stores [M/71, M/1909]. The addition appears to have replaced a wood shed and privy shown on the 1871 map.

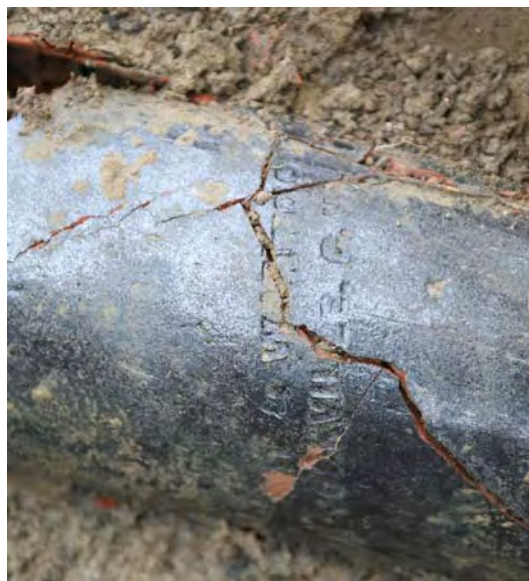
Part of an impressed maker's mark was observed on Lot 104: “_T & W_WOOD/ YORKVILLE C.W.” (Plate 13). The abbreviation “C.W.” denotes Canada West, the designation of the province of Ontario between 1841 and 1867. Both Lots 104 and 97 appear to extend towards the Military Stores Office in a northwest-southeast direction on the east side of the building (Figure 15). The general date of manufacture and the angle of Lot 104 indicates that it probably serviced the office, and may have been designed to help flush the privy noted on the 1871 map as per a system documented at the New Fort site (AjGu-32). During the assessment conducted for a new landscape plan at the Stanley Barracks, a drainage trench was documented between a catch basin placed at the southeast corner of the stone officers' quarters and the officers' privy. A drainage trench was also documented exiting the privy (ASI and HHI 2008:Figure C-5). The New Fort latrines were designed to receive a new flush of water whenever it rained (ASI and HHI 2008:28) and it may be assumed that similar systems were installed in the Ordnance and Supply Yard.

Plate 13: Close up of ceramic drain pipe manufactured in Yorkville, C.W. (Lot 104).

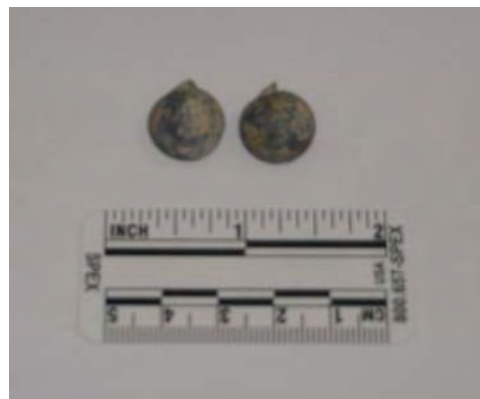
Plate 14: .58 caliber lead musket balls found in Lot 16; note uncut sprue left over from mold on top of each ball.

Lot 16, Unit 509-210. Lot 16 is the only lot to contain two .58 caliber musket balls (Plate 14; Cat.# 87), which are the ordnance that would have been used in military firearms until the gradual adoption of the repeating rifle that fired bullets, not lead shot, after circa 1840. The .58 caliber ball is smaller than the .75 caliber of the British Long Land pattern musket, and the .69 caliber of the various French muskets, all of which were used by the Canadian militia at the outbreak of the War of 1812 (Upper Canada Historical Arms Society 1963:8). This suggests that the musket balls belonged to an American soldier. Lot 16 also contains a bullet casing (Cat.# 92) of undetermined caliber.

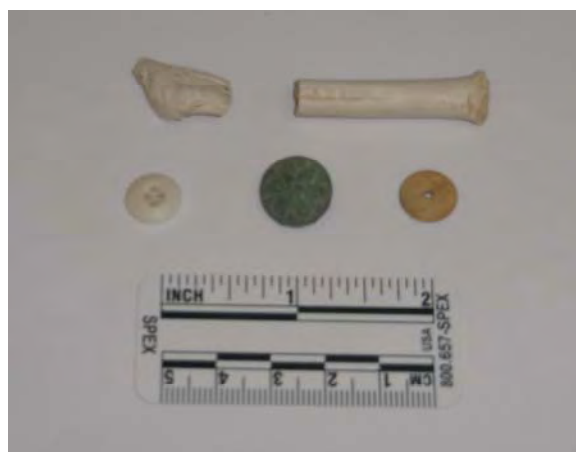
Plate 16: Personal items. Top left-right: Smoking pipe with lion in relief Cat.#37, Murray of Glasgow #813. Bottom left-right: Buttons, Cat.#335, 817, 815.

Lot 75, Unit 520-276. This buried A horizon was sealed below the Military Store Office, which apparently did not contain a full basement. Few of the smoking pipe stems recovered during the assessment possessed maker's marks, however, one stem (Plate 16; Cat.# 813) recovered from Lot 75 is from a pipe manufactured by Murray of Glasgow circa 1830-1861 (Kenyon 1982). Several bone buttons, a fancy domed brass button with gilt (Plate 16; Cat.# 817), and eight ceramic fragments including both pearlware and refined white earthenware were also recovered. Six hand wrought nails (Cat.# 823) were also found in Lot 75, along with 50 machine cut nails, indicating the refurbishment of a structure that may have been on the common in the early nineteenth century.

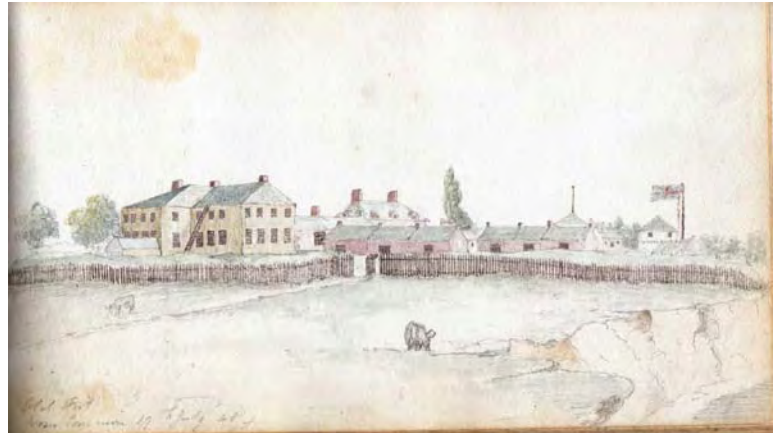
Figure 20: “Old Fort From Common, 19th July 1848.” In private New Zealand collection, courtesy Fort York National Historic Site. (S/1848, Appendix A).

In the foreground of an 1848 watercolour depicting this area as pasture (Figure 20), a channel or gully opening towards the eroding cliff of Lake Ontario is in process of forming. The cow in the foreground appears to be in danger of descending into this gully. The evidence of both the plan and the sketch support the idea of gullying or eroding ground at a slightly lower elevation in the area of the Operation 3 investigations.
