HERITAGE IMPACT AND CULTURAL LANDSCAPE ASSESSMENT

**Edwards Gardens
777 Lawrence Avenue East
City of Toronto, Ontario**

ASI File: 17CH-056

October 2017
(Revised November 2017)

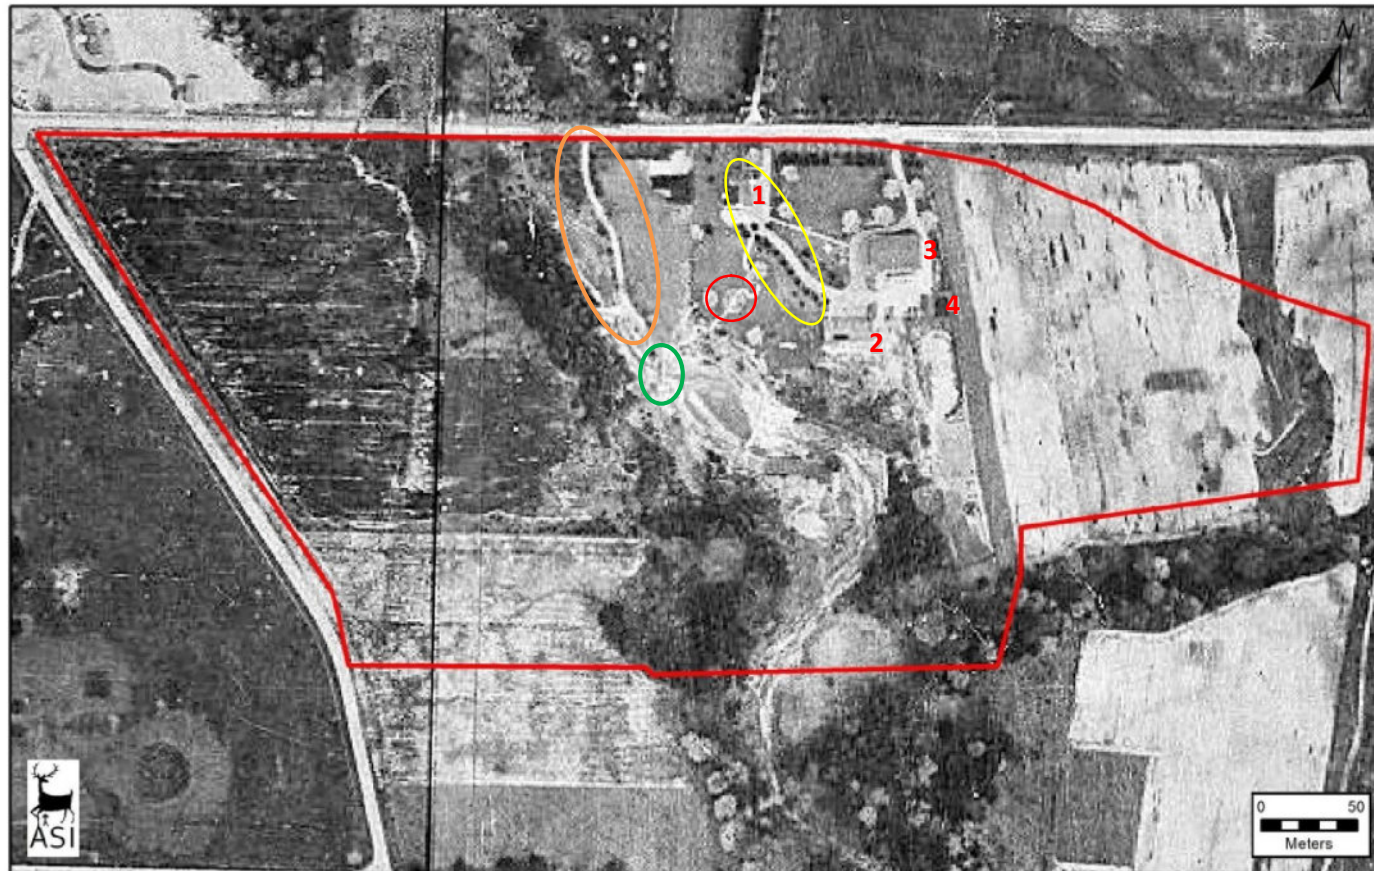
Figure 28: 1947 aerial photograph (City of Toronto)

Note further development of the pathway from the house to the barn area (outlined in yellow).

Buildings are identified as follows:

- 1: House
- 2: Garage
- 3: Barn
- 4: Lunchroom

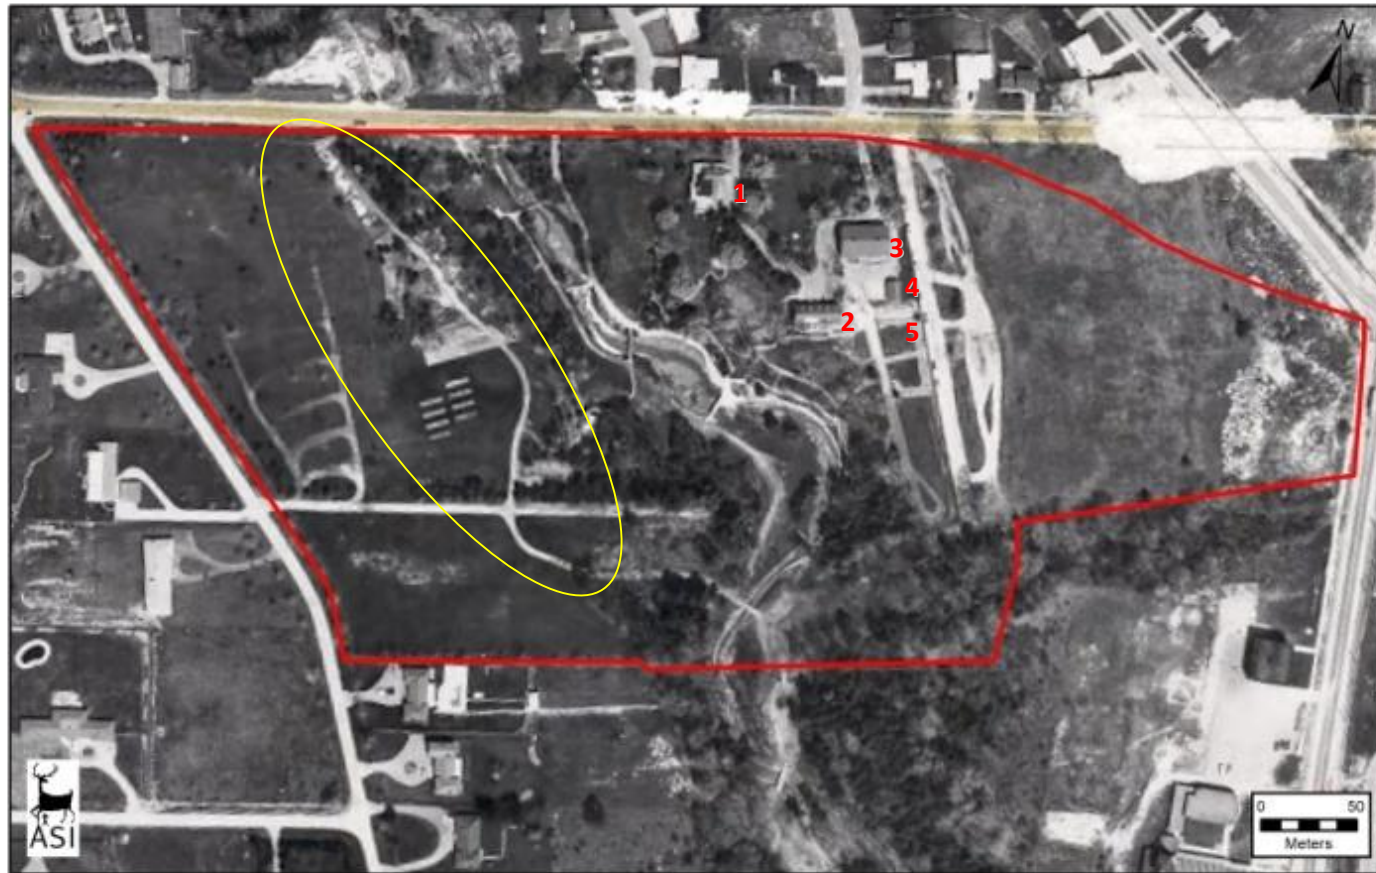
Note the addition of a north-south pathway on the west side of the creek (outlined in yellow).

Buildings are identified as follows:

- 1: House
- 2: Garage
- 3: Barn
- 4: Lunchroom
- 5: Glasshouse

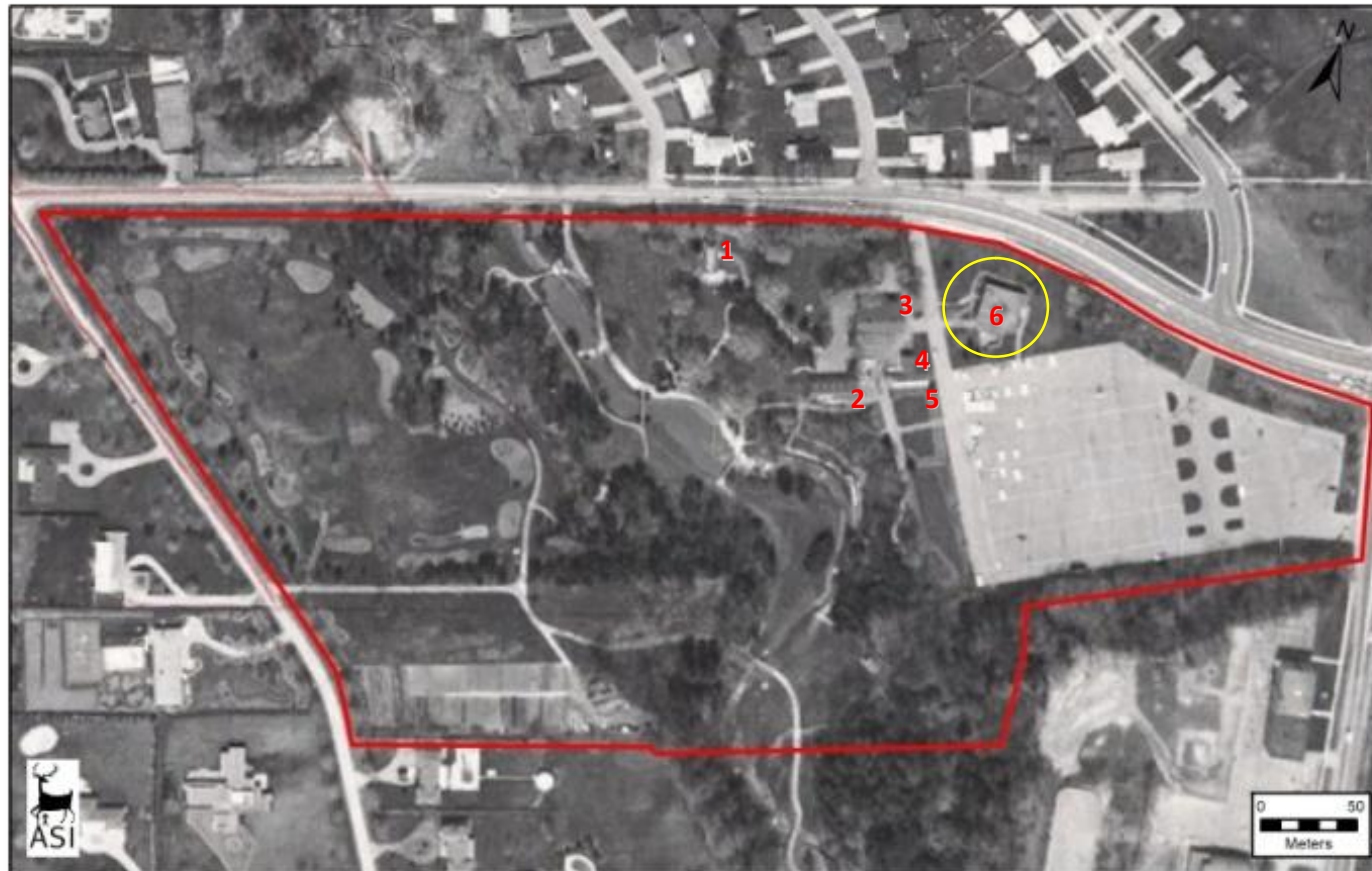
Note the addition of the Civic Garden Centre (outlined in yellow), and parking lot.

The house has been replaced by the Pavilion (1).

- 1: Pavilion
- 2: Garage
- 3: Barn
- 4: Lunchroom
- 5: Glasshouse
- 6: Civic Garden Centre

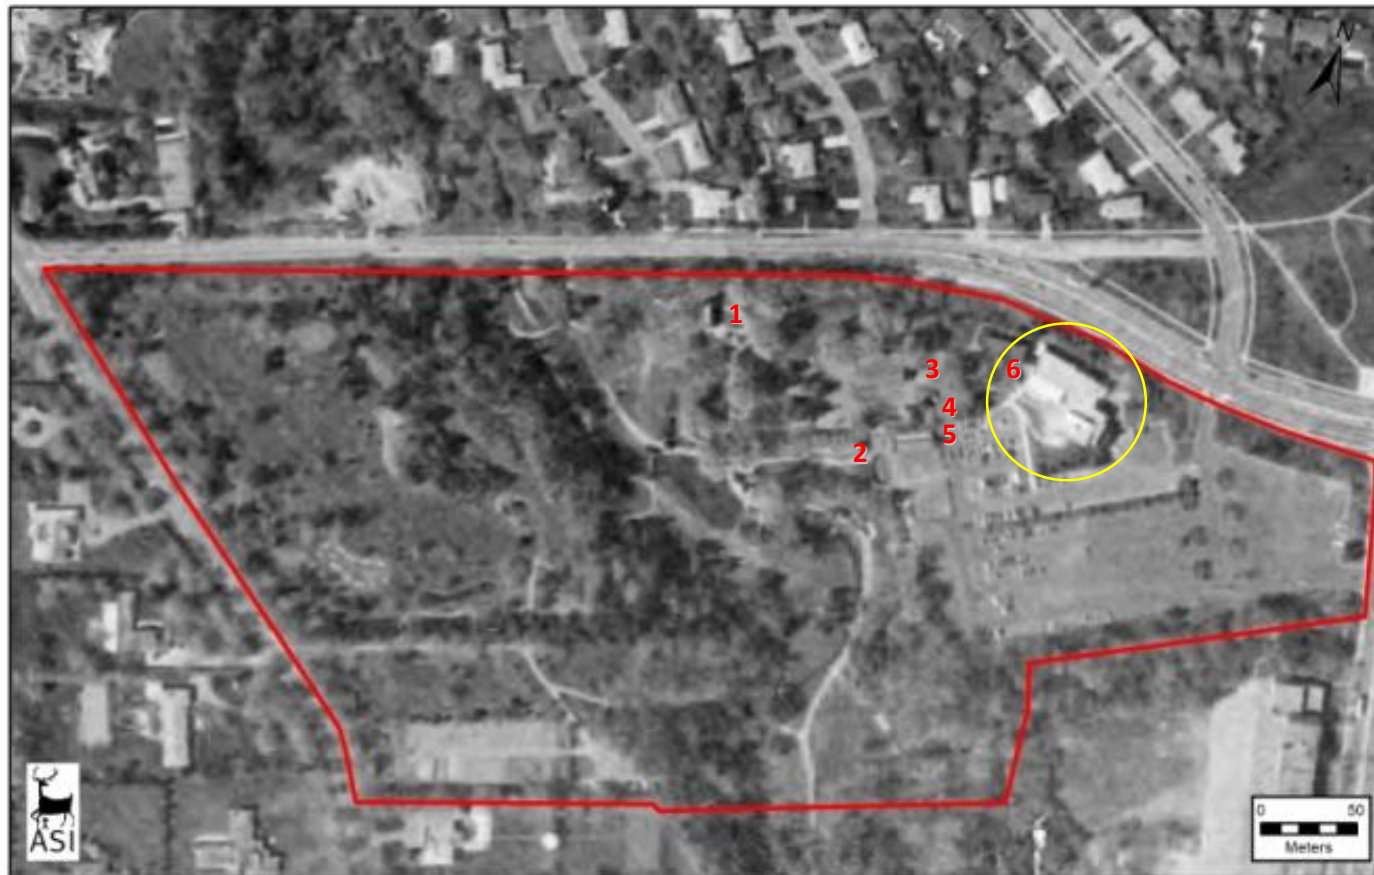
Note the addition
to the Civic Garden
Centre (outlined in
yellow).

Buildings are
identified as
follows:

- 1: Pavilion
- 2: Garage
- 3: Barn
- 4: Lunchroom
- 5: Glasshouse
- 6: Civic Garden
Centre

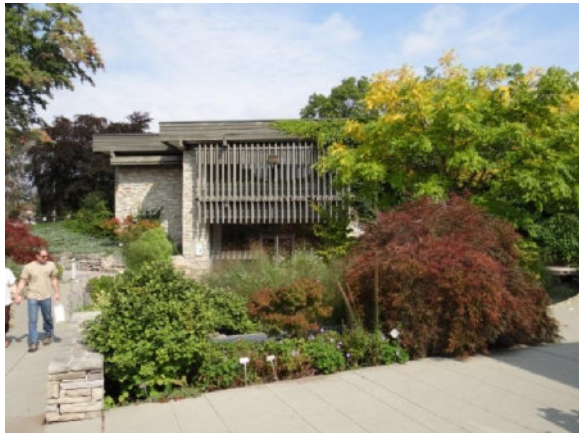
Figure 35: South elevation of 1964 Civic Garden Centre building

The Civic Garden Centre is a complex of three buildings. Architect Raymond Moriyama completed the original building in 1964 (Figure 35). It is a two-storey modernist building with a modified square footprint, with rough stone bearing walls and natural wood detailing. It houses administrative offices and features an exterior terrace with floral displays below grade, and is surrounded by heavily landscaped planters.

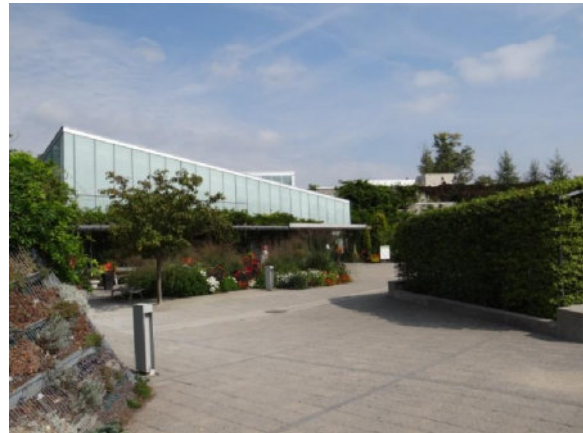
Figure 36: 2005 addition to Civic Garden Centre, with 1976 addition behind

The newest portion of the Civic Garden Centre was completed in 2005 by Montgomery Sisam architects and added a front gift shop and entry pavilion to the front of the Markson addition (Figure 36). It features a green roof and glass cladding.

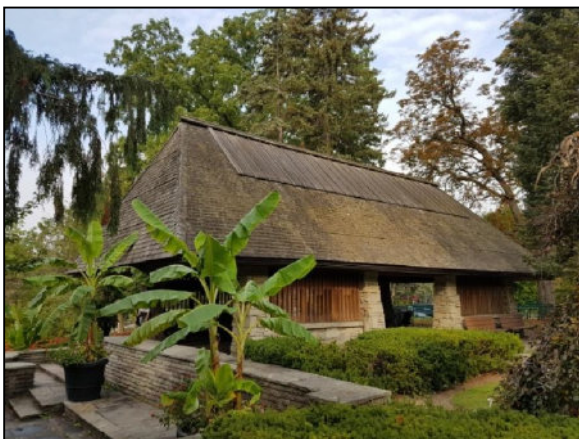
Figure 37: Pavilion - Northwest view

The pavilion is a rectangular one-and-a-half storey open-air structure built in the arts and crafts style on the location of the property's original farmhouse, after it was damaged by a fire and subsequently demolished. The pavilion was built on a concrete slab foundation with flagstone paving and uses the foundations and terraces of the original structure. The building stands on eight stone tapered pillars and cedar and redwood is used for the screens, benches, soffits and trim. The trusses are BC fir. The roof features cedar shakes and plywood gusset plates with translucent fibre glass panels. A description of the Pavilion's setting can be found in Section 3.3.3. Views associated with the Pavilion are found in Section 3.4.

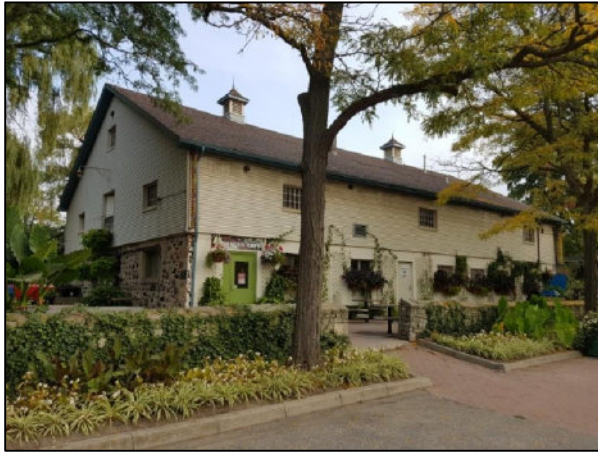
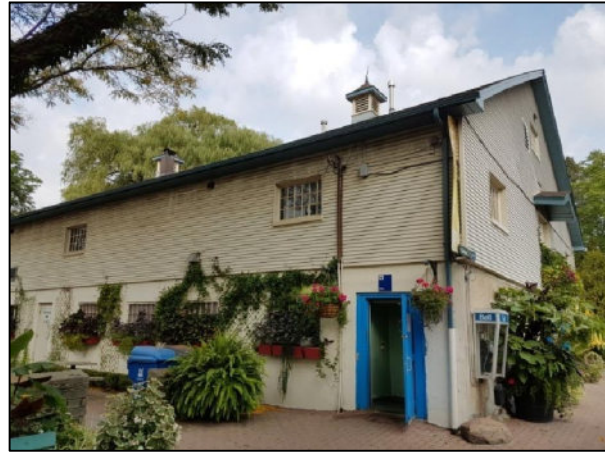
The south elevation (Figure 41 and Figure 42) contains three entrances, each with a metal door, which provide access to a bathroom, cafe and the internal maintenance spaces. Six window openings are present on the first floor, with four containing wood windows divided into 3X7 panes of glass, while the two western-most windows are sliders. The sills are obscured by large windowsill planters, though the sills throughout the first floor of the rest of the building are composed of pre-cast concrete. Wood lattice panels have been affixed to the walls to enable vine growth. The second storey contains three wood windows divided into 3X6 panes of glass. A vent has been installed on the west portion of the facade.

Figure 41: Barn - South Elevation

Figure 42: Barn - South Elevation

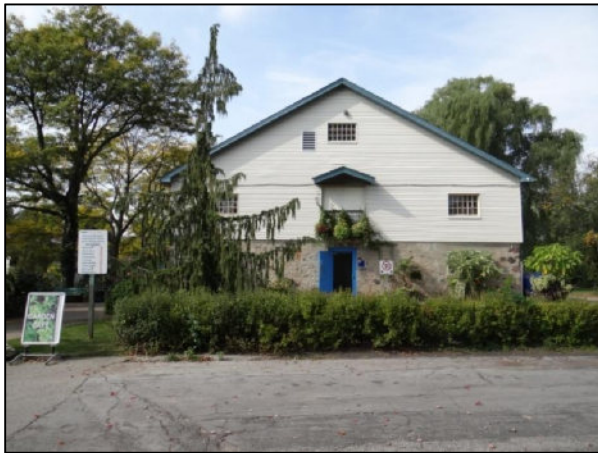
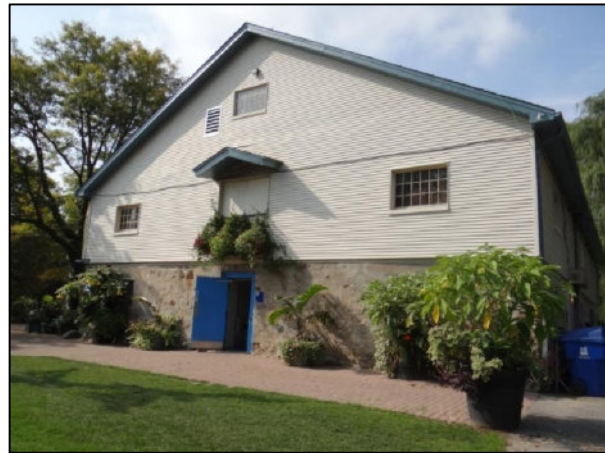
The east elevation (Figure 43 and Figure 44) consists of a single metal door centrally located providing access to a bathroom, flanked by two wooden windows divided into 3X6 panes of frosted glass and precast concrete sills (Figure 45). The second-storey contains the aforementioned loft window, which is enclosed with wooden French doors. A metal railing has been installed and large hanging plants obscure much of its design. Above the loft window is a small gable awning with aluminum fascia and soffits. The second storey contains two wooden windows divided into 3X6 panes of glass (Figure 46). An identical window is located beneath the gable adjacent to a modern vent.

Figure 43: Barn - East Elevation

Figure 44: Barn - East Elevation

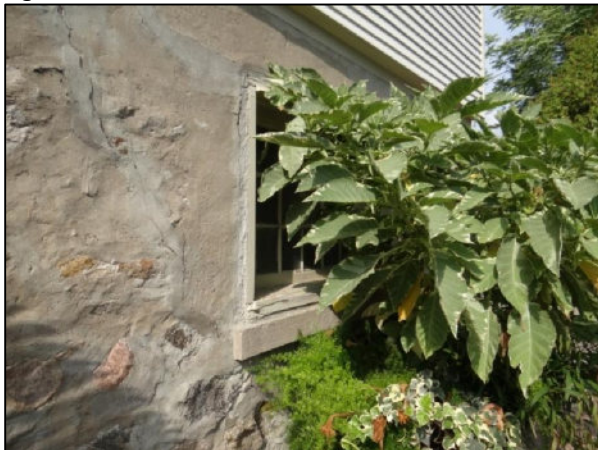
Figure 45: Barn - East Elevation Window

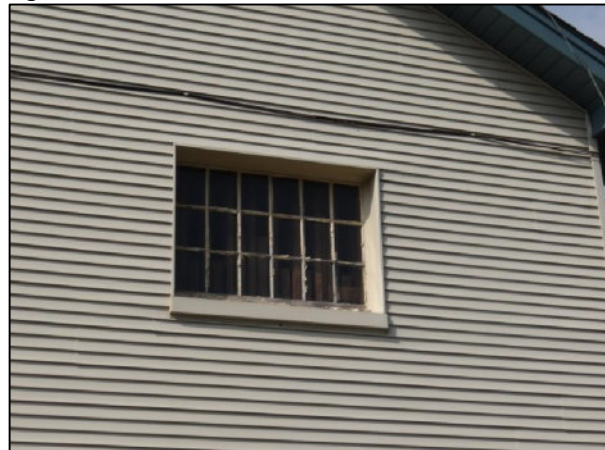
Figure 46: Barn - East Elevation Window

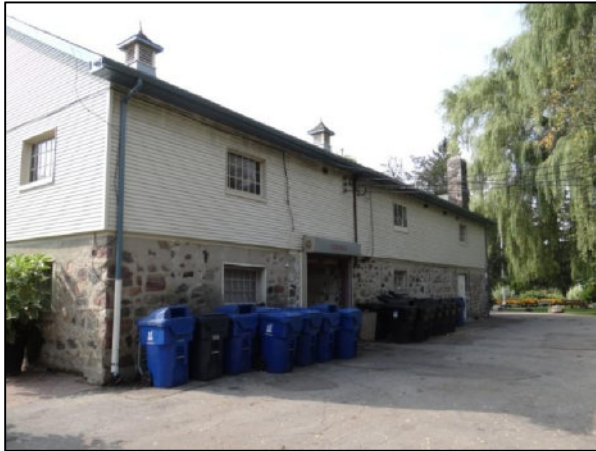
Figure 47: Barn - North Elevation

The main feature of the north elevation is a large garage entrance with a roll-up door (Figure 47). An additional servicing door is located on the west portion of the building (Figure 48). Additional fenestration on the first floor is limited to a single wood window divided into 3X6 panes of glass on the eastern-most portion of the facade and a centrally located pair of wood windows that have had the panes removed and boarded up, apart from two vents which have been installed (Figure 49). The window sits above a pre-cast concrete sill and the facade around the window has been heavily parged. The second storey contains three wood windows, two of which are identical and divided into 3X6 panes of glass while the central window consists of three large panes within a wood window. From this elevation, the internal chimney is visible, clad in stone (Figure 50). Interior investigations determined that the chimney is comprised of brick (and similarly, the two cupolas have been reused for heating ventilation).

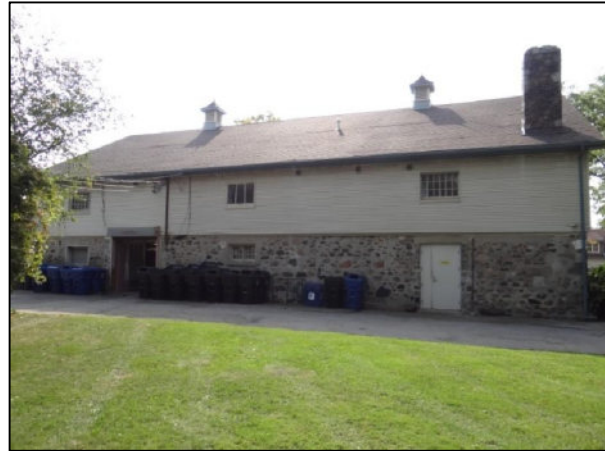
Figure 48: Barn - North Elevation

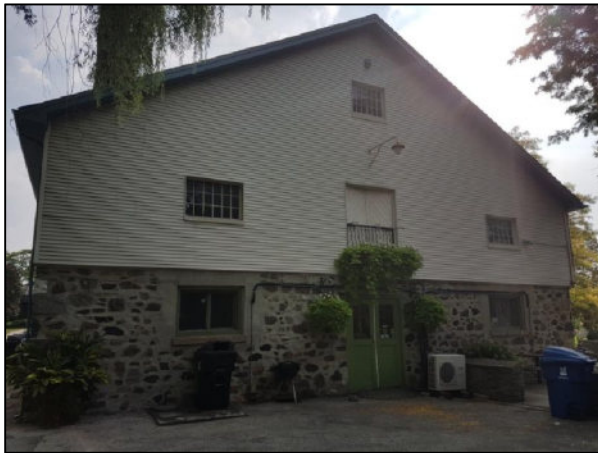
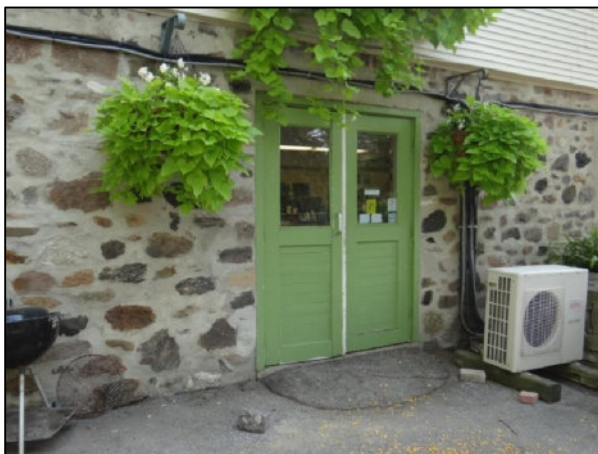
Finally, the west elevation contains a double-door entrance that provides access to a cafe (Figure 51 and Figure 53). On both sides of the entrance are wood slider windows above pre-cast concrete sills (Figure 54). The areas around the windows have been heavily parged. The second storey is identical to the east elevation with a central loft window, enclosed with wood French doors and a metal railing (Figure 52). In lieu of the small gable awning that is found above the loft window on the east elevation, the west elevation has an acorn light attached to a metal pole affixed to the building. On both sides of the loft window are wood windows divided in 3X6 panes of glass and an identical window is found beneath the gable.

Figure 51: Barn - West Elevation

Figure 53: Barn - West Elevation Doorway

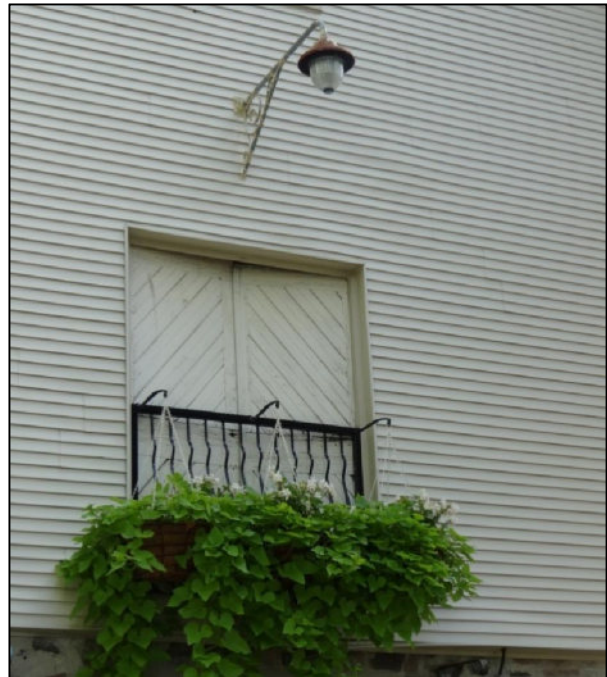
Figure 52: Barn - West Elevation Loft Window

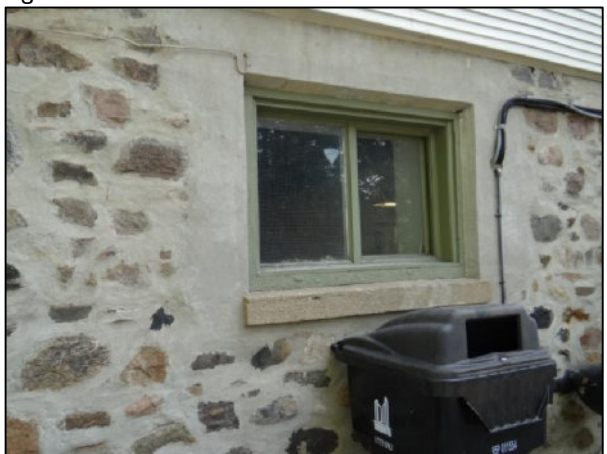
Figure 54: Barn - West Elevation Window

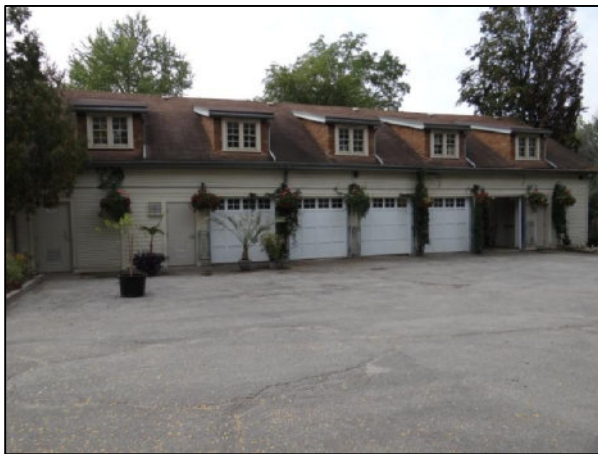
Figure 55: Garage - North Elevation

The north elevation primarily consists of five roll-up garage doors (Figure 55). Two metal doors providing access to the garage and services are located to the east of the row of garage doors (Figure 56). A recessed metal door is located to the west of the garage doors and provides access to the upper storey

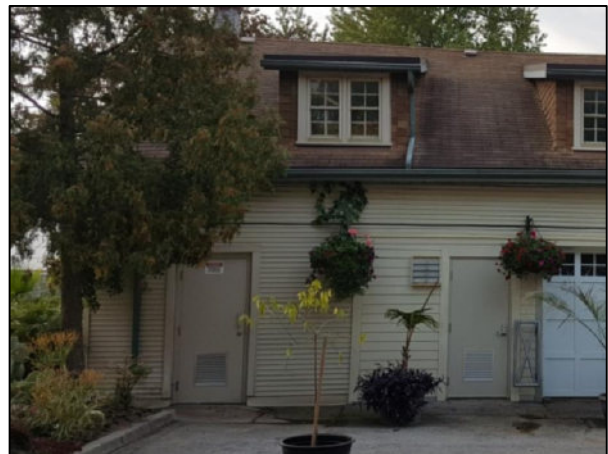
Figure 56: Garage - North Elevation Doors

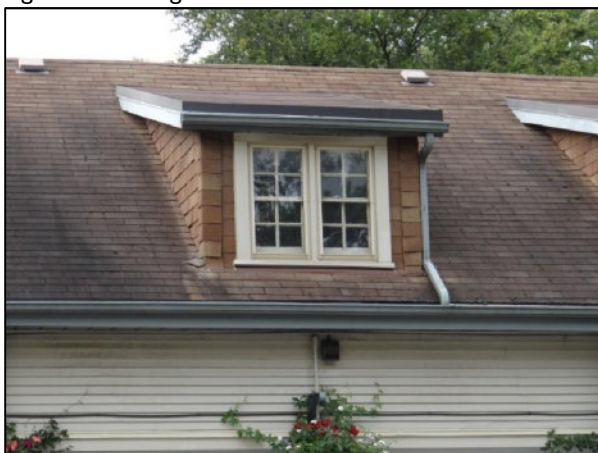
Figure 57: Garage - North Elevation Dormer

(Figure 58). The upper storey contains a series of five dormers, each with a pair of double-hung four-over-four wood windows (Figure 57).

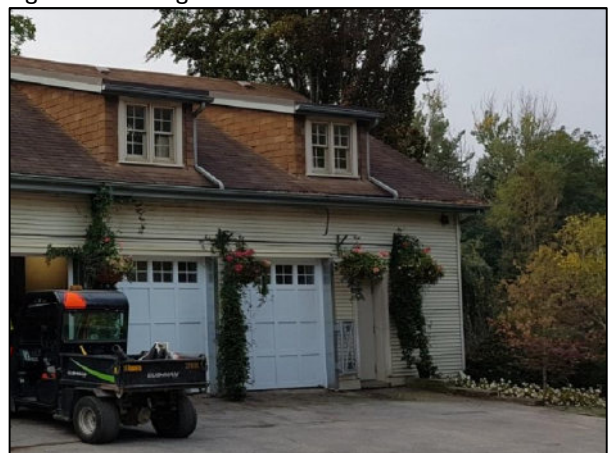
Figure 58: Garage - North Elevation Garage Doors

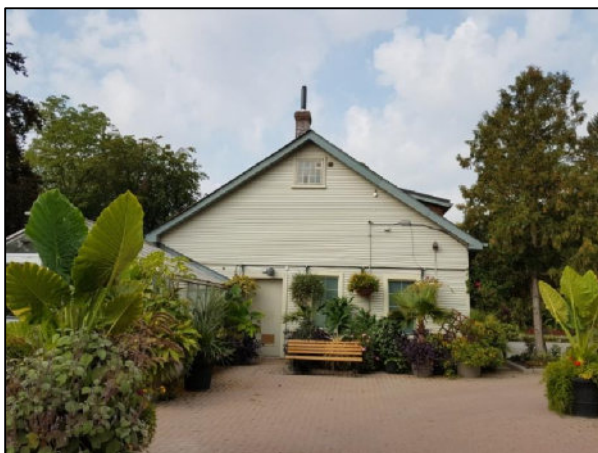
Figure 62: Garage - East Elevation

The east elevation contains a portion of the greenhouse on the southeast corner (Figure 63). A metal door and two fixed windows divided into eight panes of glass make up the rest of the first floor (Figure 62). A wood window divided into twelve panes of glass is located beneath the gable.

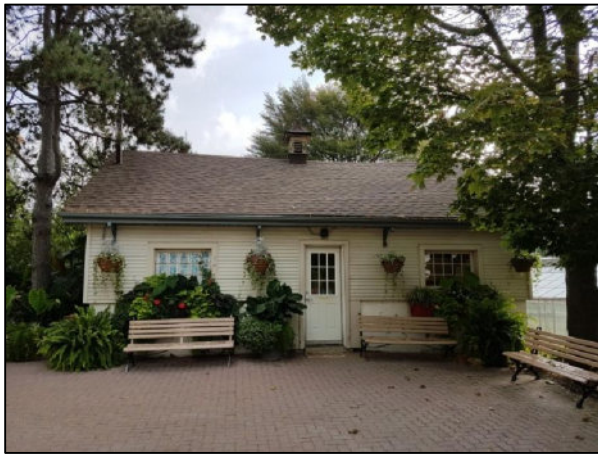
Figure 64: Lunchroom - West Elevation

The west elevation consists of a central door flanked by wood windows divided into 5X3 panes of glass (Figure 64). Four brackets are affixed to the facade to allow for the hanging of flowerpots. The north elevation is largely obscured by vegetation though a large vertical opening with a wood door is located beneath the gable (Figure 65). The east elevation consists of three wood windows divided into 5X3 panes of glass (Figure 66 and Figure 67). Two of the windows have been largely boarded up. The south elevation consists of one fixed wood window divided into nine panes of glass beneath the gable (Figure 68).

- (a) Retention in place of the existing buildings that form the Maintenance Complex is recommended. Should removal be required, the removal of the Lunchroom, as the smallest building would have the least impact on the complex of buildings and the courtyard they form. Should the lunchroom be removed, consideration should be given to maintaining the enclosed space of the courtyard through other means such as the use of vegetation or structure.

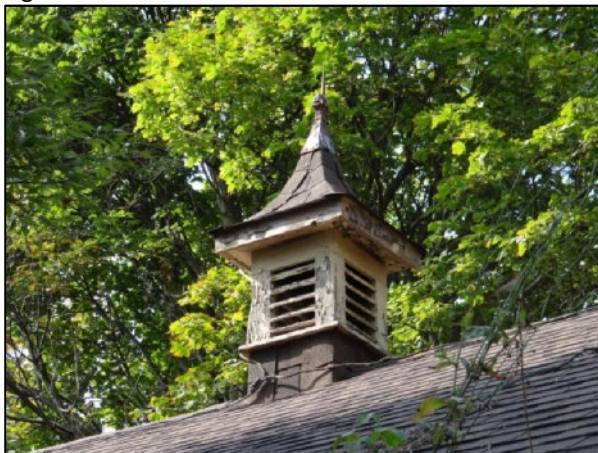
Figure 69: Lunchroom - Cupola

The Lunchroom is a one-storey building on a rectangular footprint with a gable roof with asphalt shingles and aluminum siding. The building sits on a poured concrete foundation (Figure 70). A central cupola (Figure 69) and an internal brick chimney both protrude from the peak of the roof.

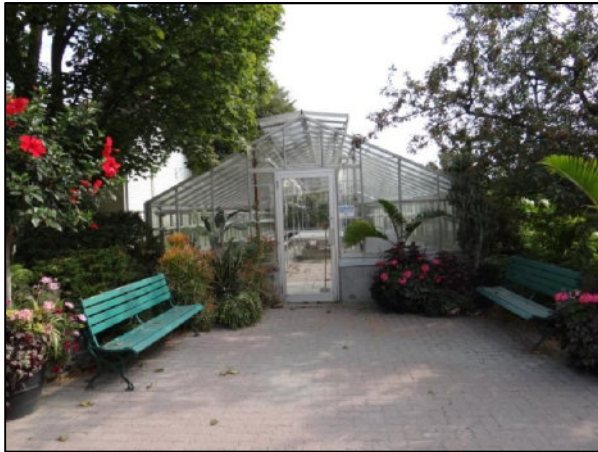
Figure 71: Glasshouse - West Elevation

The Glasshouse building is a narrow rectangular building comprised entirely of steel and glass and a cement foundation (Figure 71 to Figure 74). The building is accessed via a door on the west elevation (Figure 71).

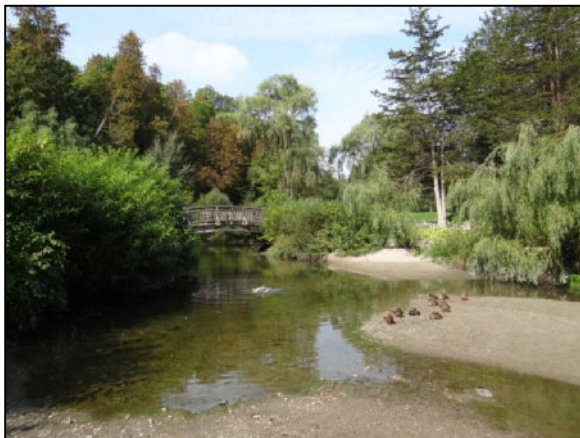
Figure 94: View of Bridge 1 spanning creek, looking east.

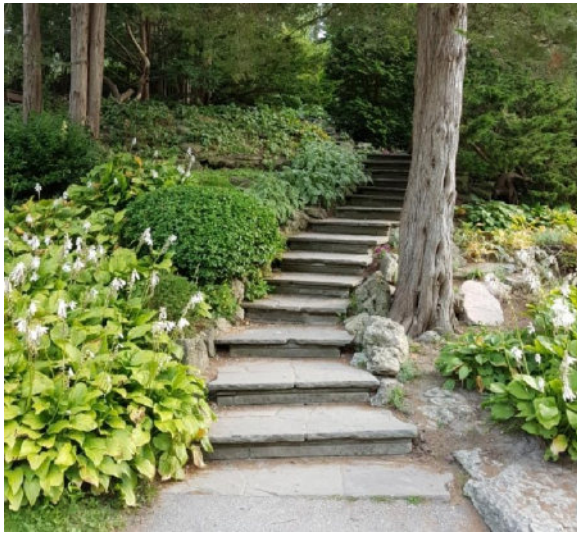
Figure 96: Flagstone steps ascending the ravine slope. Across the pathway from Bridge 1, looking northeast.

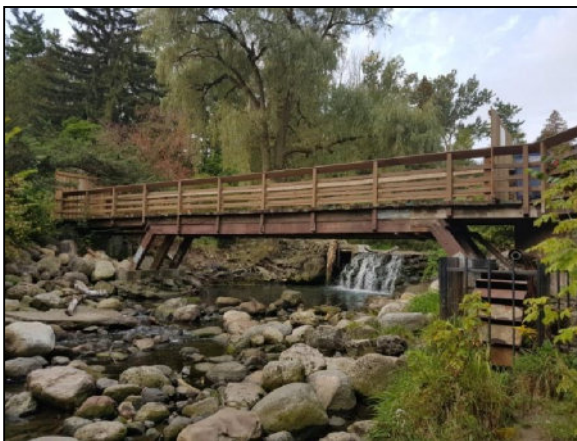
Bridge 2 (Figures 98-100) is a flat wooden pedestrian bridge with a viewing deck on the east side. It sits just downstream of an artificial waterfall in the creek constructed of rubble stone and flagstone (Figures 99-100). The flagstone also forms a structure in the creek which appears to be a fish ladder. A steel water wheel is located immediately downstream from the bridge on the east bank of the creek (Figure 101). This was likely installed by Rupert Edwards, intended to echo the much larger waterwheel built by Alexander Milne to power his mill in the early nineteenth century (Kennedy 2017:147). Adjacent to Bridge 2 is another flagstone staircase, with a steel railing, which connects to the same pathway as the first staircase (Figure 97).

Figure 98: Bridge 2 with waterfall and waterwheel, looking west.

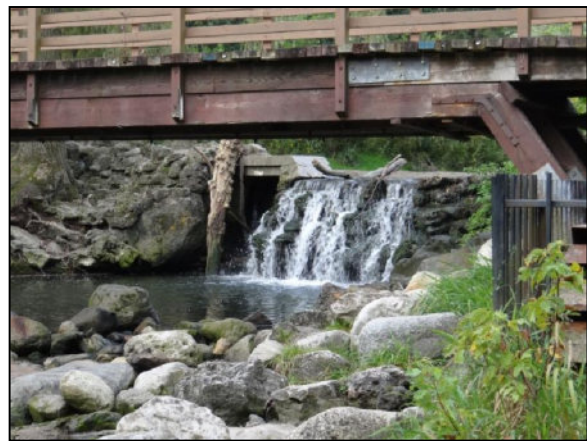
Figure 99: View of Bridge 2, waterfall and fish ladder, looking west.

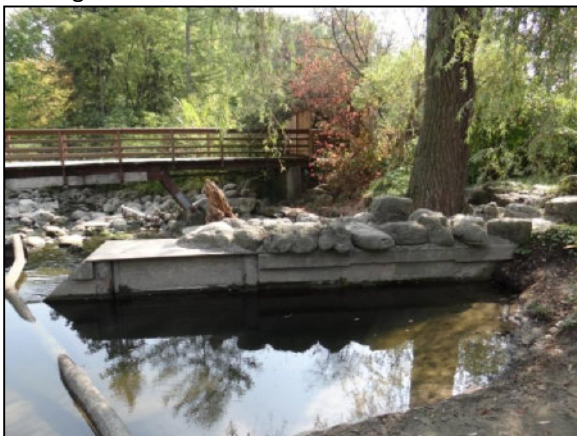
Figure 100: Easterly view of bridge 2, waterfall and fish ladder structure.

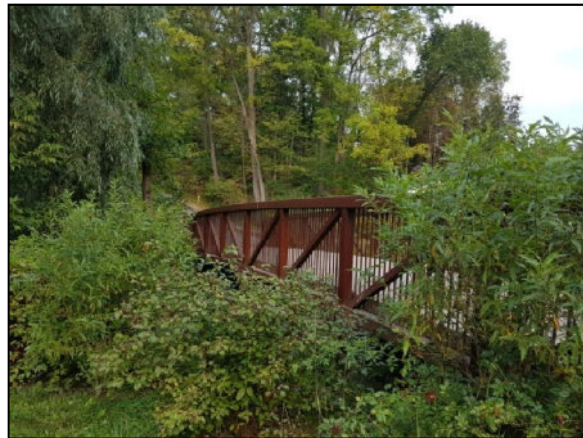
As the creek turns back towards the south, Bridge 3, the southernmost bridge on the property crosses the creek (Figure 105). It is a slightly arched steel pedestrian bridge. Other bridges on the property include a flat steel and wooden pedestrian bridge south of the parking lot area and a small, flat wooden pedestrian bridge south of the public washrooms on the southernmost corner of the property.

Figure 105: Bridge 3, towards the southern edge of the property.

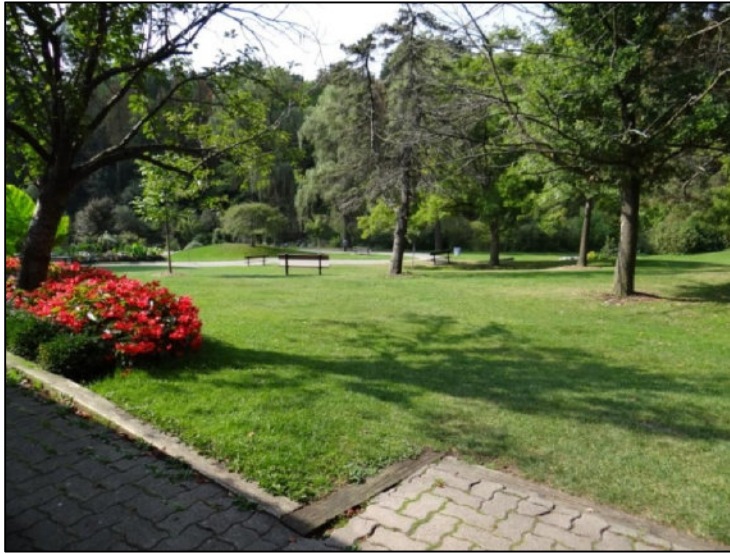
Figure 117: View from the Pavilion

- 1. View from the Pavilion** includes gently sloped terrain with the creek and dense vegetation acting as a backdrop.

The proposed bridge will have an impact on a number of the views outlined in Section 3.5. While the design, location and orientation of the bridge are still to be finalized, certain views will be obstructed or altered based on the location of the bridge, while the impact on other views will be dependent on the location of the landing spot on the east side of the valley. The addition of the bridge may cause the loss of certain historical vantage points that have been experienced by visitors to the site since it opened to the public in 1956. It is important to note that not all views should be considered equally important, and while some views will be obstructed, other views may be improved or new views may be created.

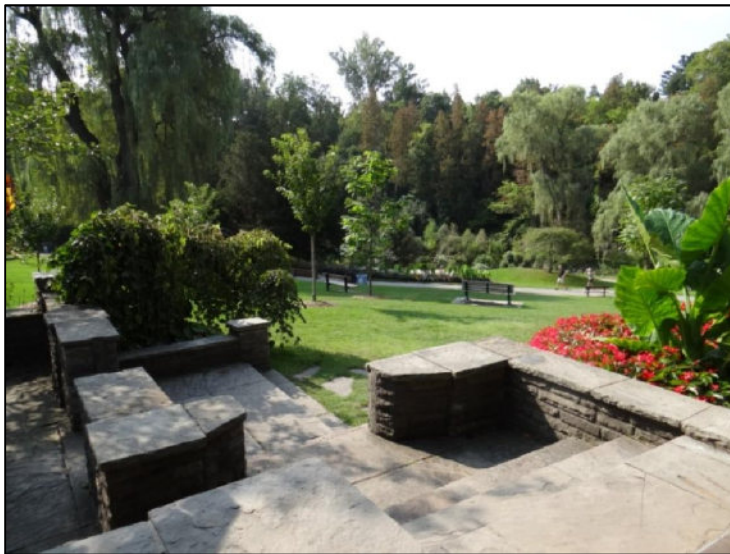
Figure 118: View from the Pavilion

- 2. View from the Pavilion** showing the gentle slope of the terrain as it approaches the circulation paths and the river. The view is framed by a large willow tree that dominates this portion of the lawn.

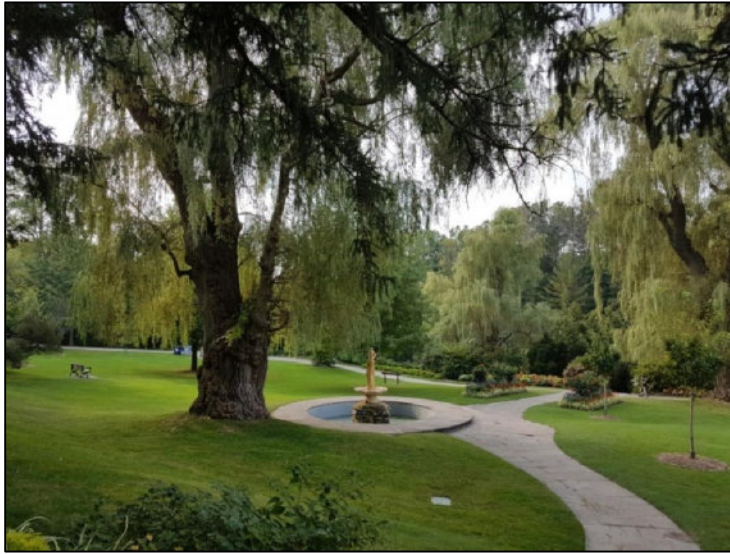
Figure 119: View of the Fountain and Lawn

- 3. View of the fountain and lawn** where a fountain and path have been located on this site since 1947. The original path formed a semi-circle to the east as it passed beyond the fountain before meeting the straightened portion of the path to the south.

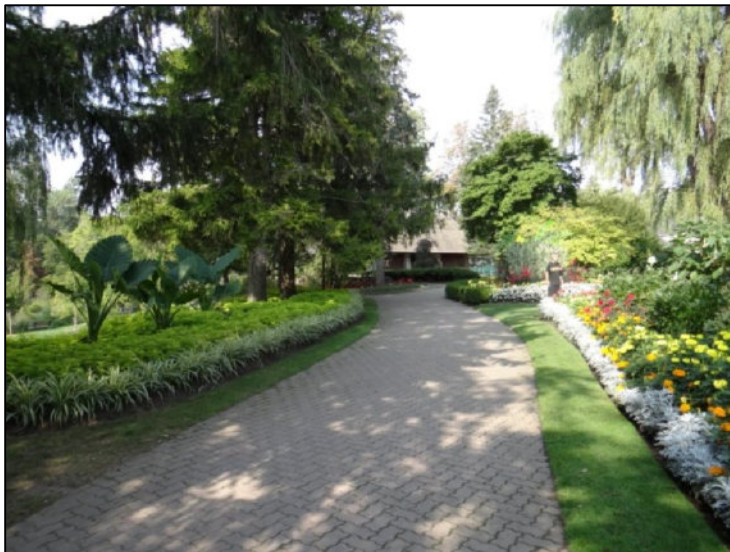
Figure 120: View of the Pavilion and the path to/from the Maintenance Complex

- 4. View of the Pavilion from the path between the pavilion and the Maintenance Complex.** The pathway is located on an original pathway between the original Milne Residence and the complex of buildings to the south east. The path is one of the few remnants of the original circulation patterns of the property's agricultural era.

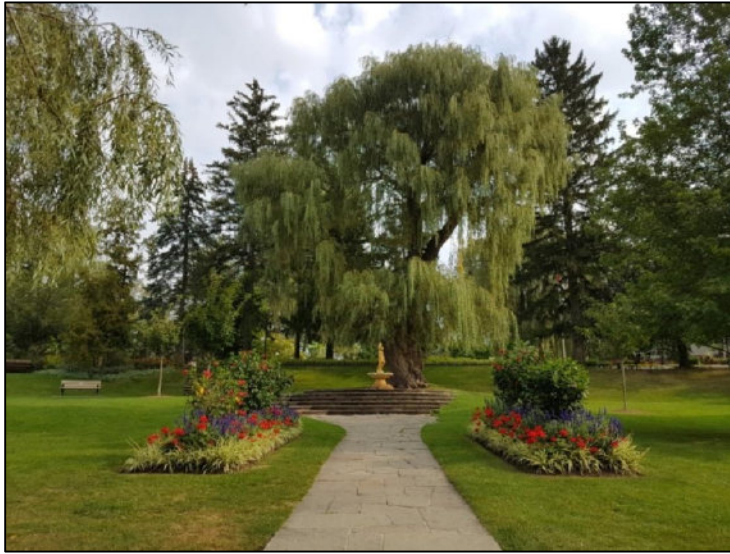
Figure 121: View towards the Fountain from the South

5. **View towards the fountain from the south** where the view from the south of the fountain has been intact for at least 70 years. The existing statue at the centre of the fountain is not original.

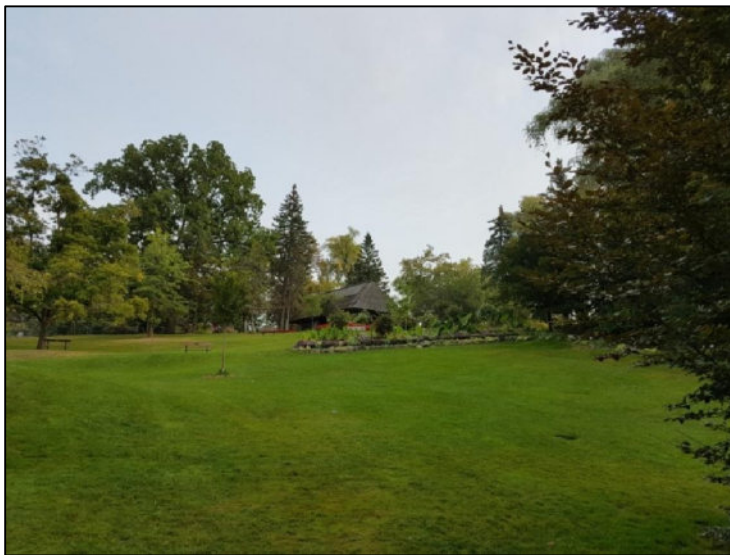
Figure 122: View towards the Pavilion from the South

6. **View towards the Pavilion from the south** displaying the prominence of the Pavilion. Though clearly visible on the crest of the slope, the Pavilion's natural materials allow the building to harmonize with its surroundings. The wide-open landscape accentuates the uninterrupted views of the Pavilion in both directions.

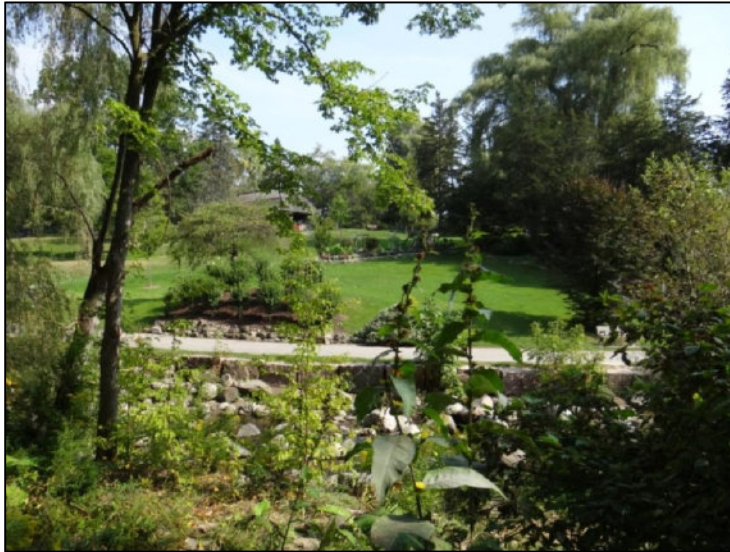
Figure 123: View of the Pavilion from the west side of the creek

7. **View of the Pavilion from the west side of the creek** where this perspective provides a full appreciation of the change of elevation from the Pavilion to the river. The river, paths, vegetation and flower beds are all visible from this perspective.

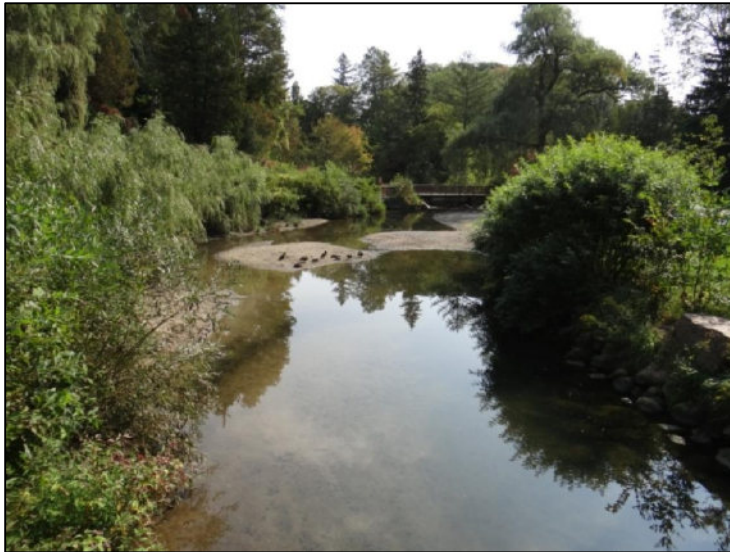
Figure 124: View of the River from Bridge 1.

8. **View of the River from Bridge 1.** The first iteration of this bridge is visible on the 1947 aerial photo. The bridge provided views of the river and acts as a focal point in the valley. This view displays the widened portion of the river as it approached the small water fall and mill downstream.

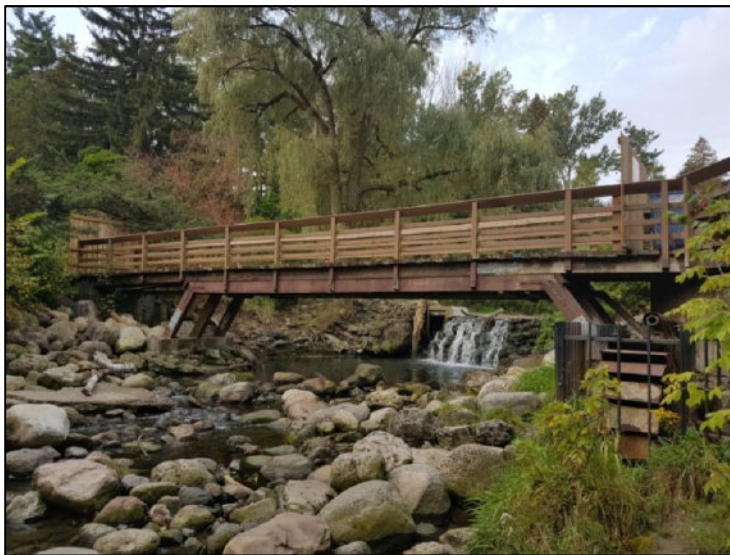
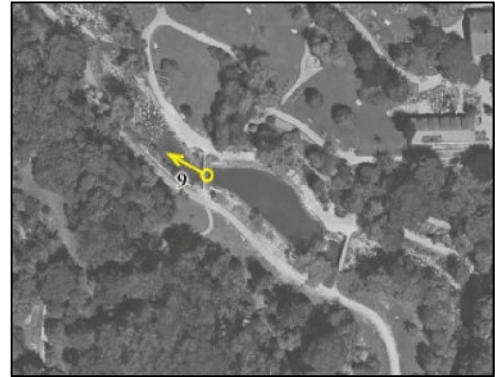
Figure 125: View of the creek from the Bridge 1

9. View of the creek from Bridge 1.

The first iteration of this bridge is visible on the 1947 aerial photo. The bridge provided views of the river and acts as a focal point in the valley. This view highlights the calm nature of the river as flows through the shallow riverbed in the distance.

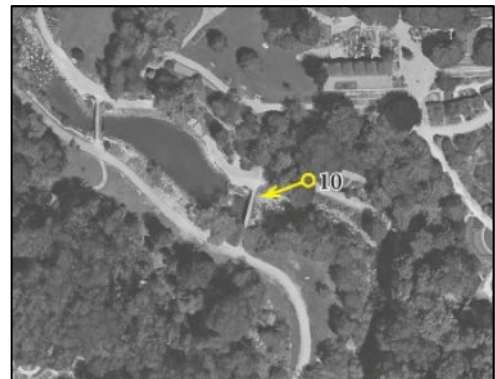
Figure 126: View of Bridge 2 from the East

10. View of Bridge 2 from the east.

This entirely artificial view was created between 1947 and 1953. The bridge (not original), the waterwheel and waterfall were all constructed by Edwards and meant to provide an idyllic natural appearance.

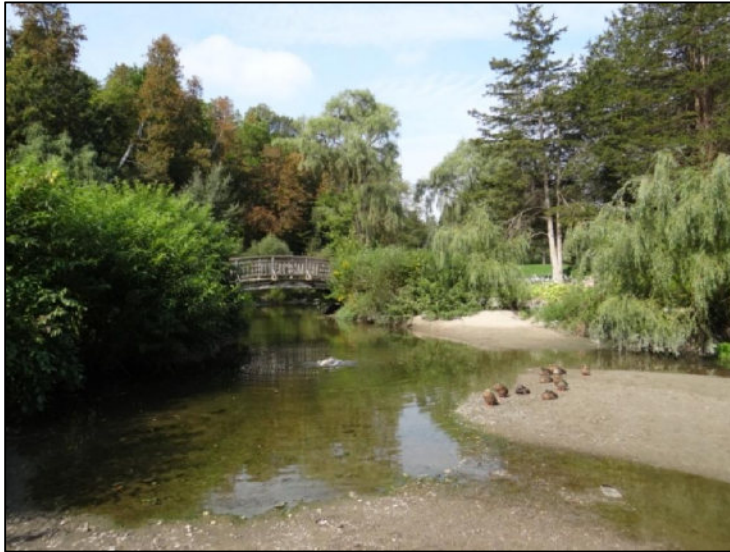
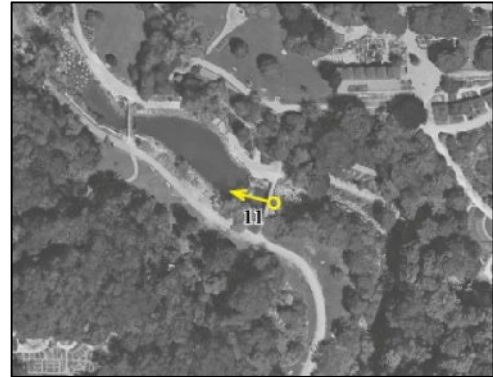
Figure 127: View of Bridge 1 from creek bed. (Bridge 2 was not accessible at the time of the field review, however this photo generally represents the view from Bridge 2).

11. The westward view from Bridge 2 where the adjacent bridge is prominently on display. The vegetation lining the riverbank and along the valley provides both a frame and backdrop for the view.

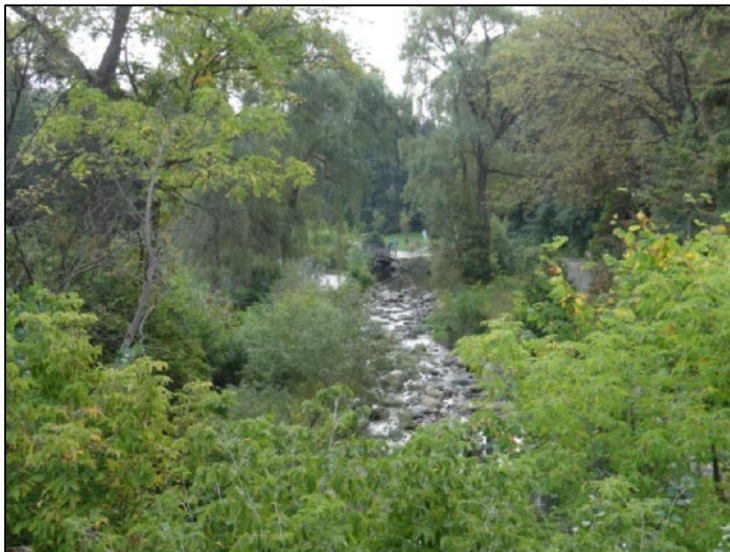
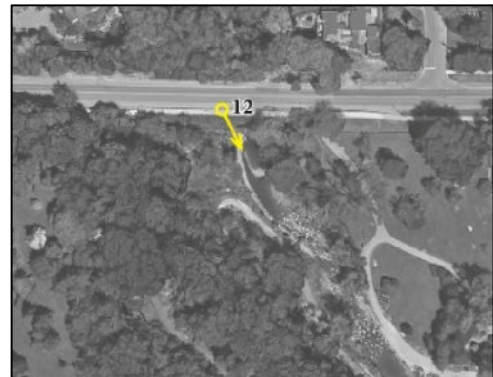
Figure 128: View from the Lawrence Avenue East Bridge

12. The view from the bridge spanning Wilket Creel on Lawrence Avenue East provides an exemplary view of Edwards Gardens including the river, pedestrian bridges and vegetation within the valley.
