HERITAGE IMPACT AND CULTURAL LANDSCAPE ASSESSMENT

**Edwards Gardens
777 Lawrence Avenue East
City of Toronto, Ontario**

ASI File: 17CH-056

October 2017
(Revised November 2017)

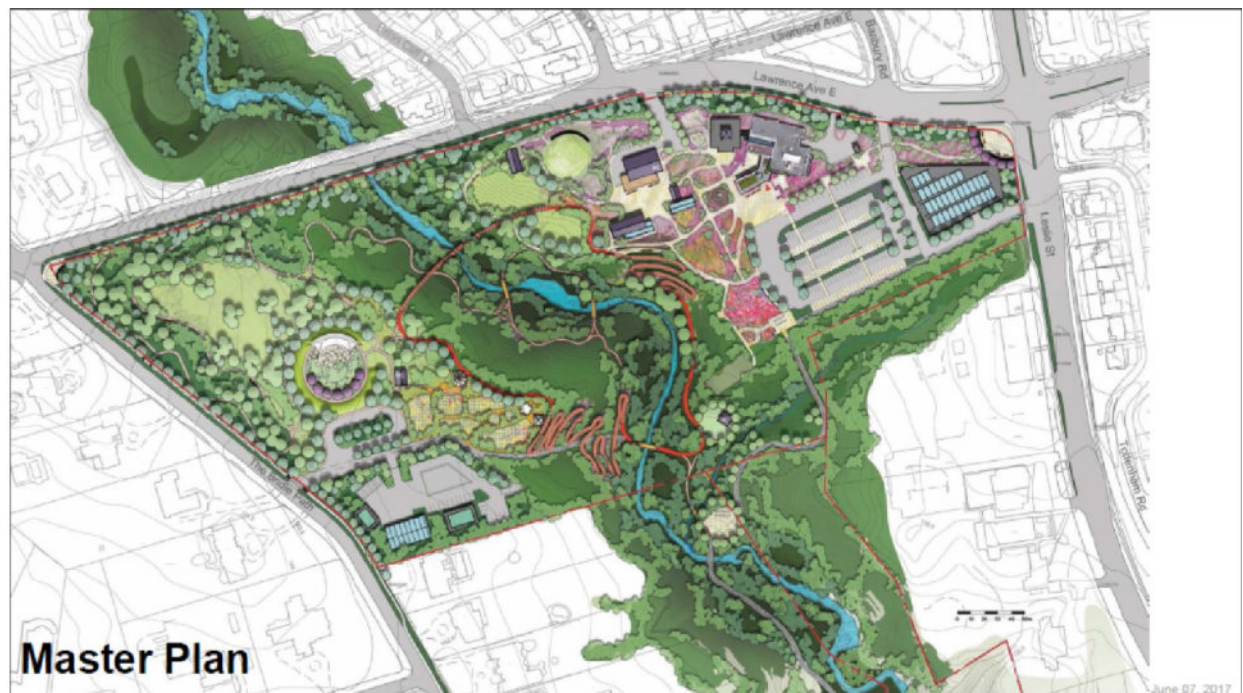
Figure 129: Master Plan concept

The intention of the proposed development is to enhance and revitalize Edwards Gardens and the Toronto Botanical Garden through a series of interventions which will improve circulation, accessibility and infrastructure. The Master Plan drawing (Figure 126) demonstrates the extent of the proposed changes.

- A 100+ metre bridge is proposed from the east table lands to the west table lands (area near the centre of the site) (Figure 127).
- The removal of numerous existing pathways, some close to the historic buildings, and the addition of numerous new pedestrian pathways, roads for service vehicles, and routes for vehicular circulation near the parking area.
- The possible demolition or relocation of the Lunchroom building, Barn, Maintenance Garage, and Glass House.

- A two-to-three level parking structure is proposed in the area where the surface parking lot off of Leslie is in poorest condition; one of these levels of parking may be proposed for below grade.
- The reconfiguration and expansion of gardens throughout the property.
- The redevelopment of the maintenance area in the southwest corner with the addition of a berm to act as a sound barrier.
