Archaeological Monitoring and Documentation of the Remains of the Queen's Wharf, Block 7, Fort York Neighbourhood, City of Toronto, Ontario

> Archaeological Licence P049 MCL CIF P049-139-2006 ASI File 06SP-23

> > April 2006

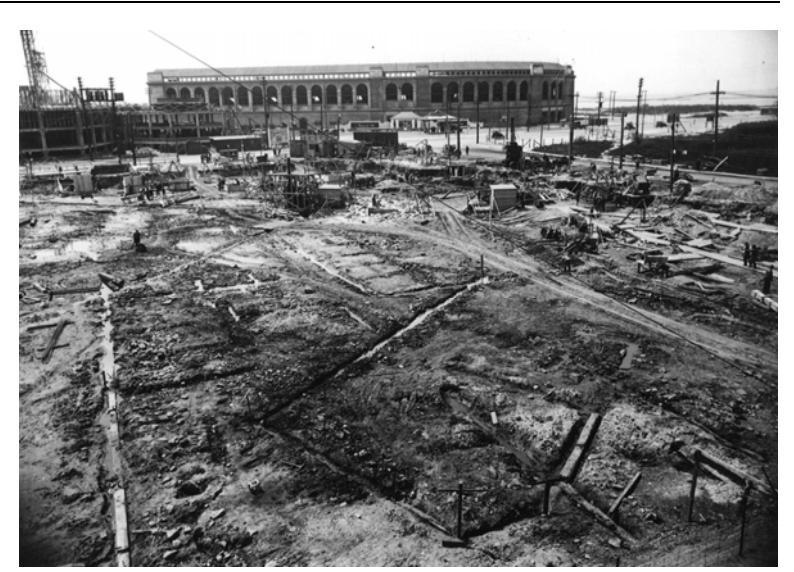
Figure 4: Exposure of remains of the Queen's Wharf during the 1927 construction of the Loblaws building at 500 Lakeshore Blvd. West. Toronto Port Authority Archives (PC 1/1/7390).

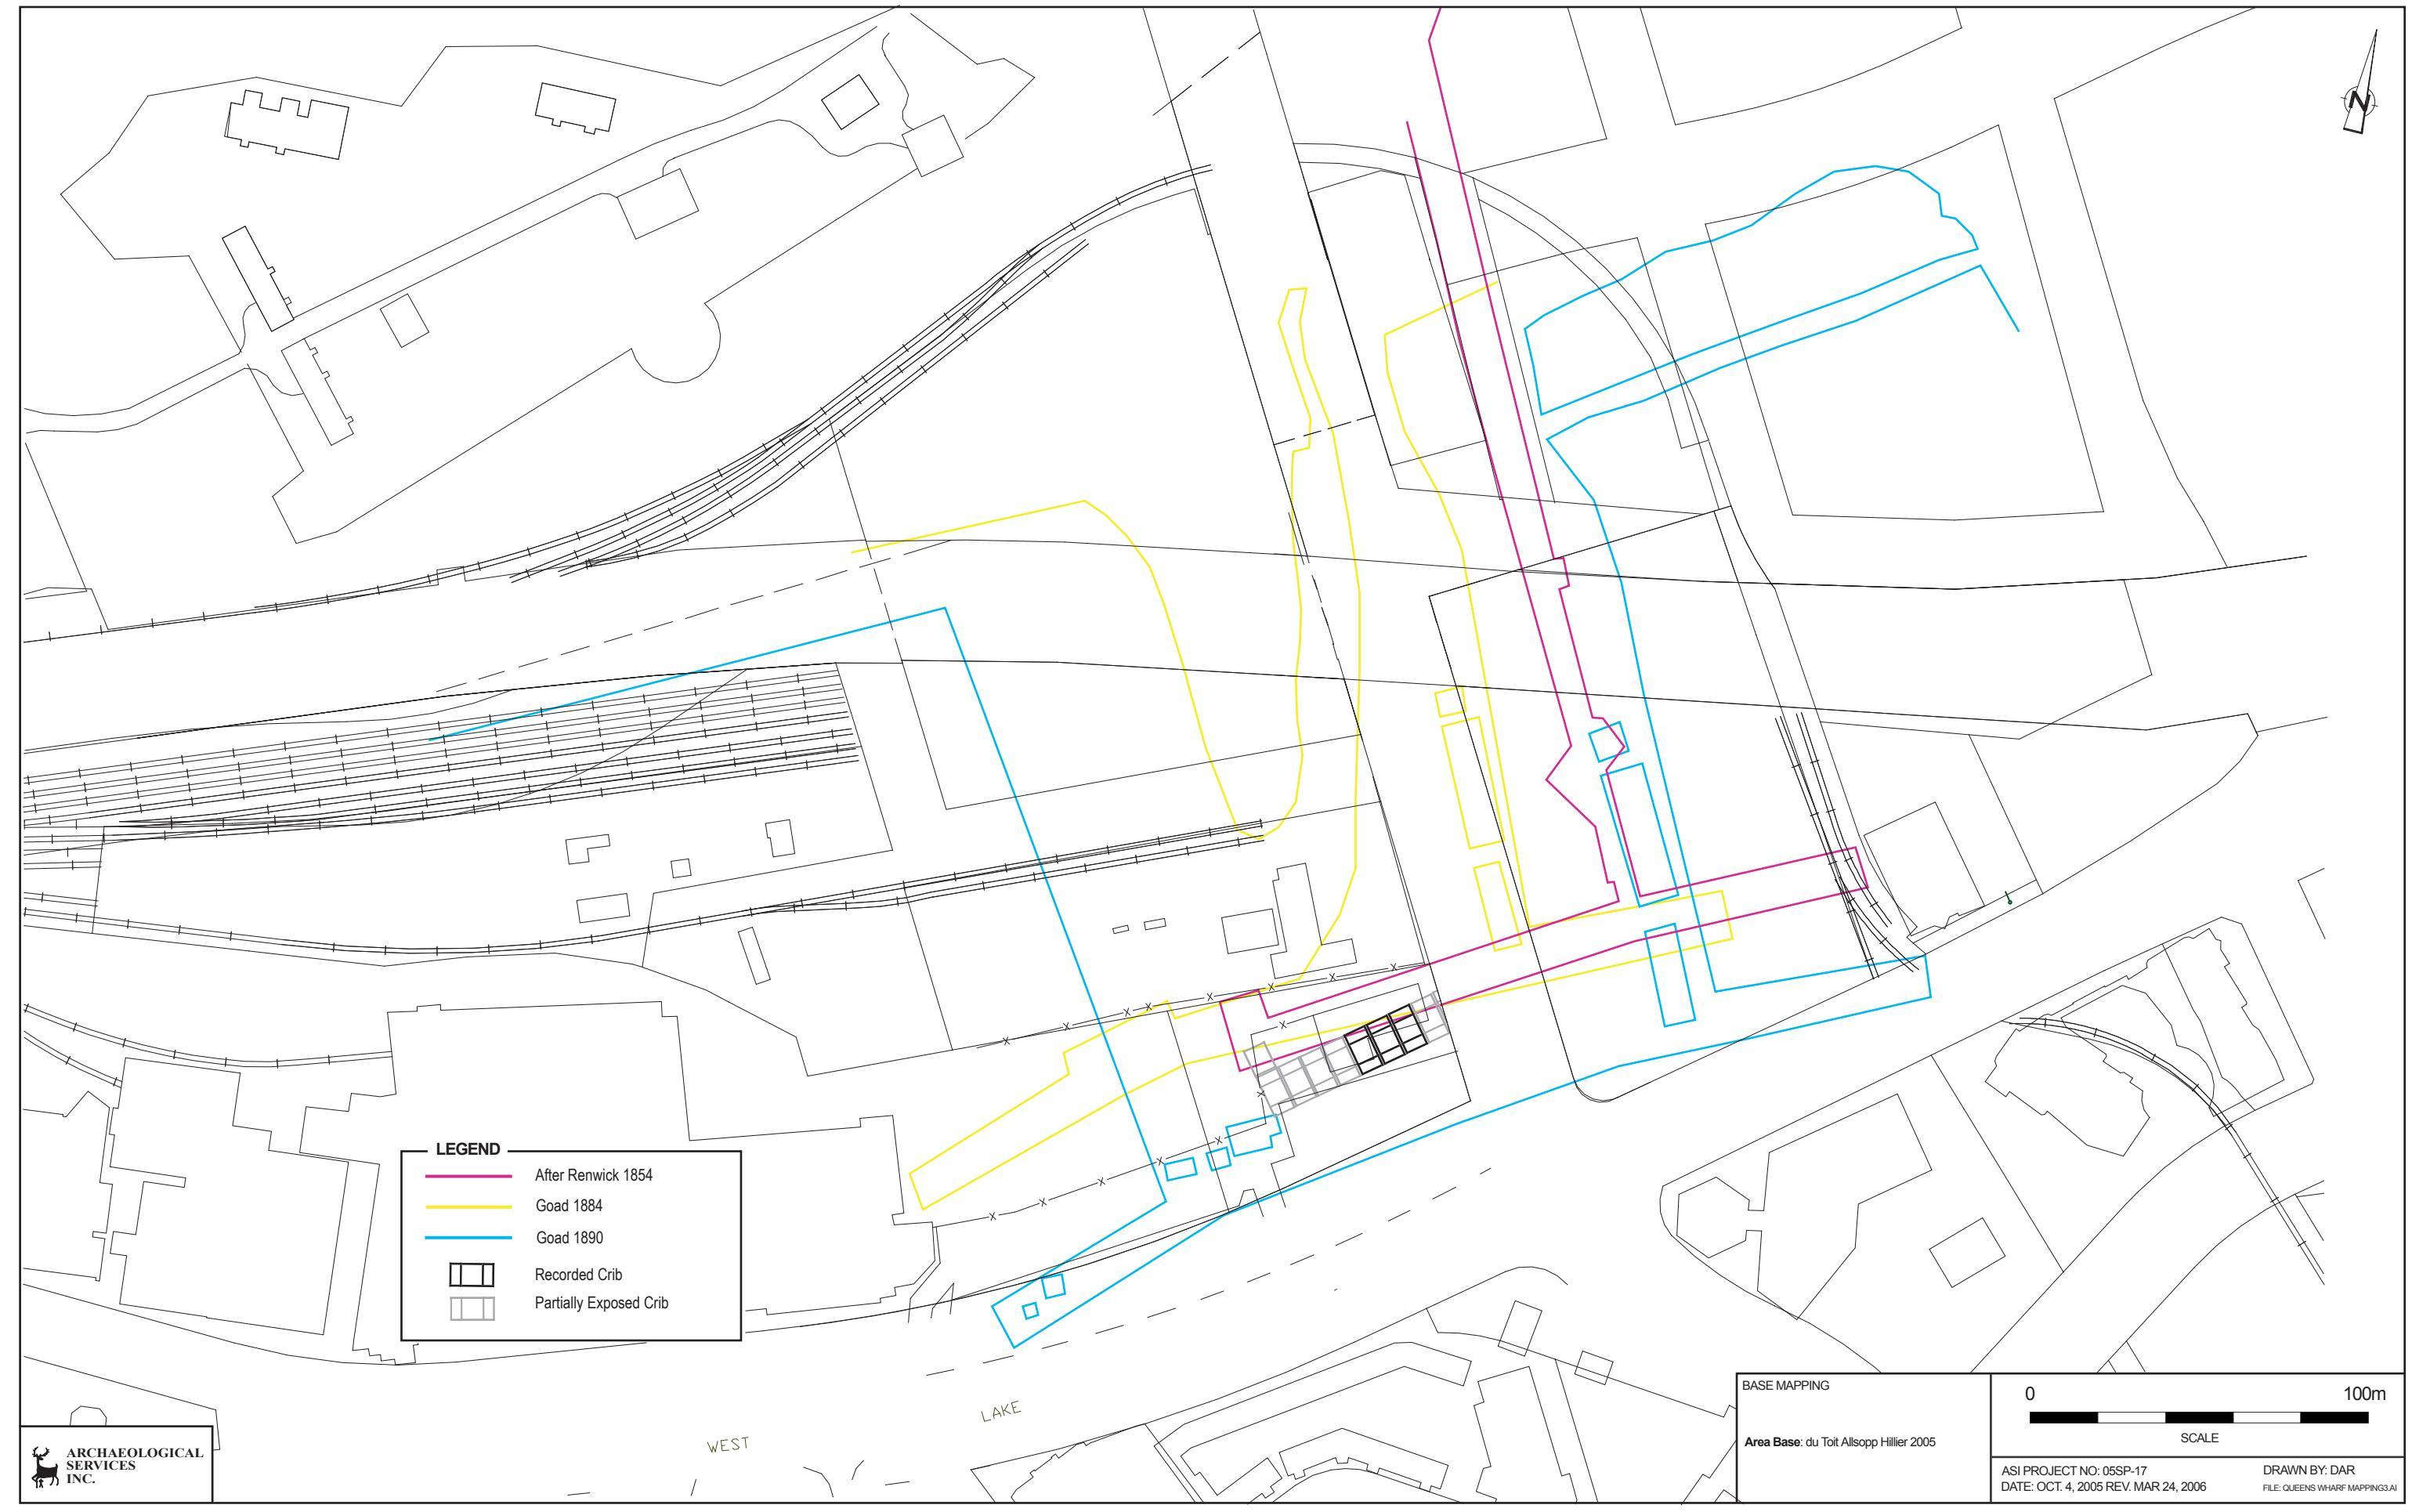
Figure 6: The Location and Configuration of the Queen's Wharf as Derived from Nineteenth Century Map Overlays and the Area of the Remains Documented During Construction

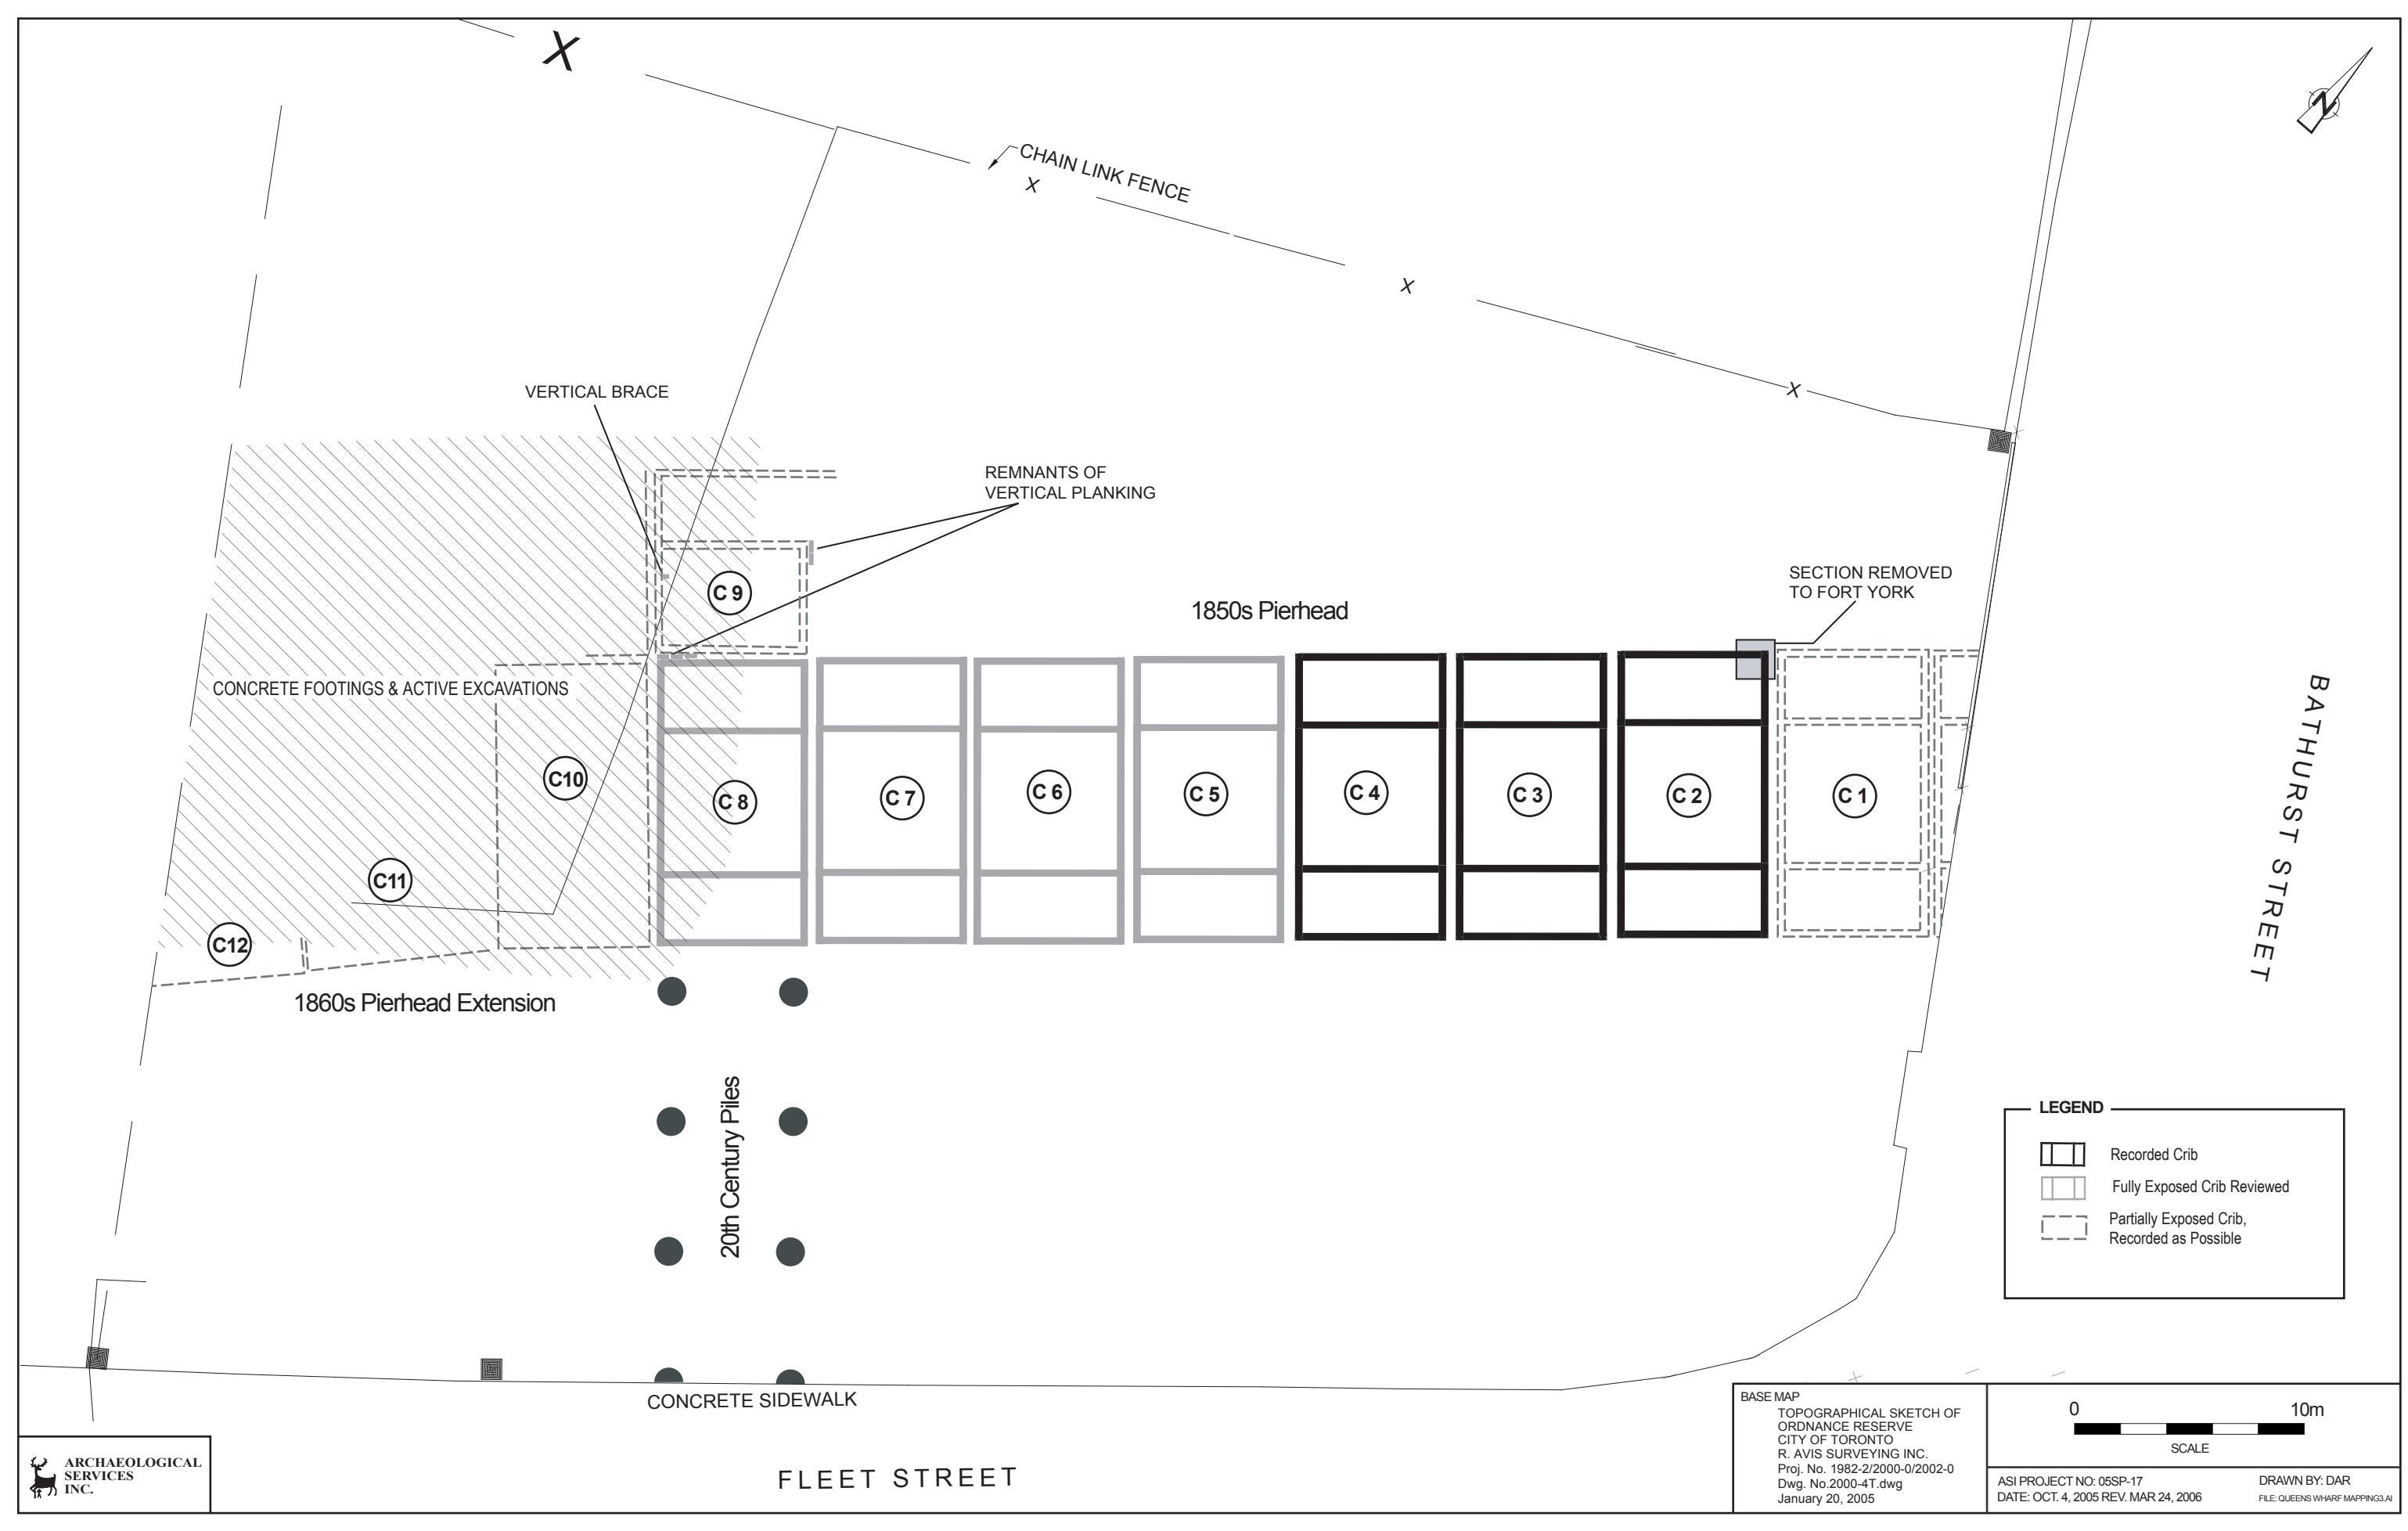
Figure 7: Archaeological Documentation of the Queen's Wharf within Block 7

Measured drawings of three of the 1850s cribs were prepared (Figures 7 -9) and the remaining fully exposed sections were examined to confirm that they corresponded in terms of their essential attributes. Meaurements and observations concerning details of the partially exposed remains, which were located at the west end of the site, were made to the extent that was possible or necessary. This portion of the property formed the active excavation area at the time of monitoring and was further compromised by the presence of a series of concrete footings related to the twentieth century development of the property that lay atop the crib work.

The cribs making up the 1850s east-west foundation of the pierhead (C2-C8, C10) measured 42' in length from north to south and 21' in width from east to west (Figures 7-11). The individual cribs consisted of a central 21' cell, flanked on its north and south sides by cells that measured 10' 6" in width and 21' in length. These cribs were separated from one another by distances ranging from three inches to almost two feet. These gaps were filled with densely packed lengths of roundwood poles, scrap lumber and other debris. Cribs 4 to 8 stood to a maximum height of ten feet, being composed of 11 courses of 11" square white pine timbers. The cribs were set directly on levelled lake clay, although in two instances (on the north side of Crib 2 and the east side of Crib 5) a large glacial erratic, seemingly in situ, was found underneath the lowermost timber, apparently having been used to balance the crib.

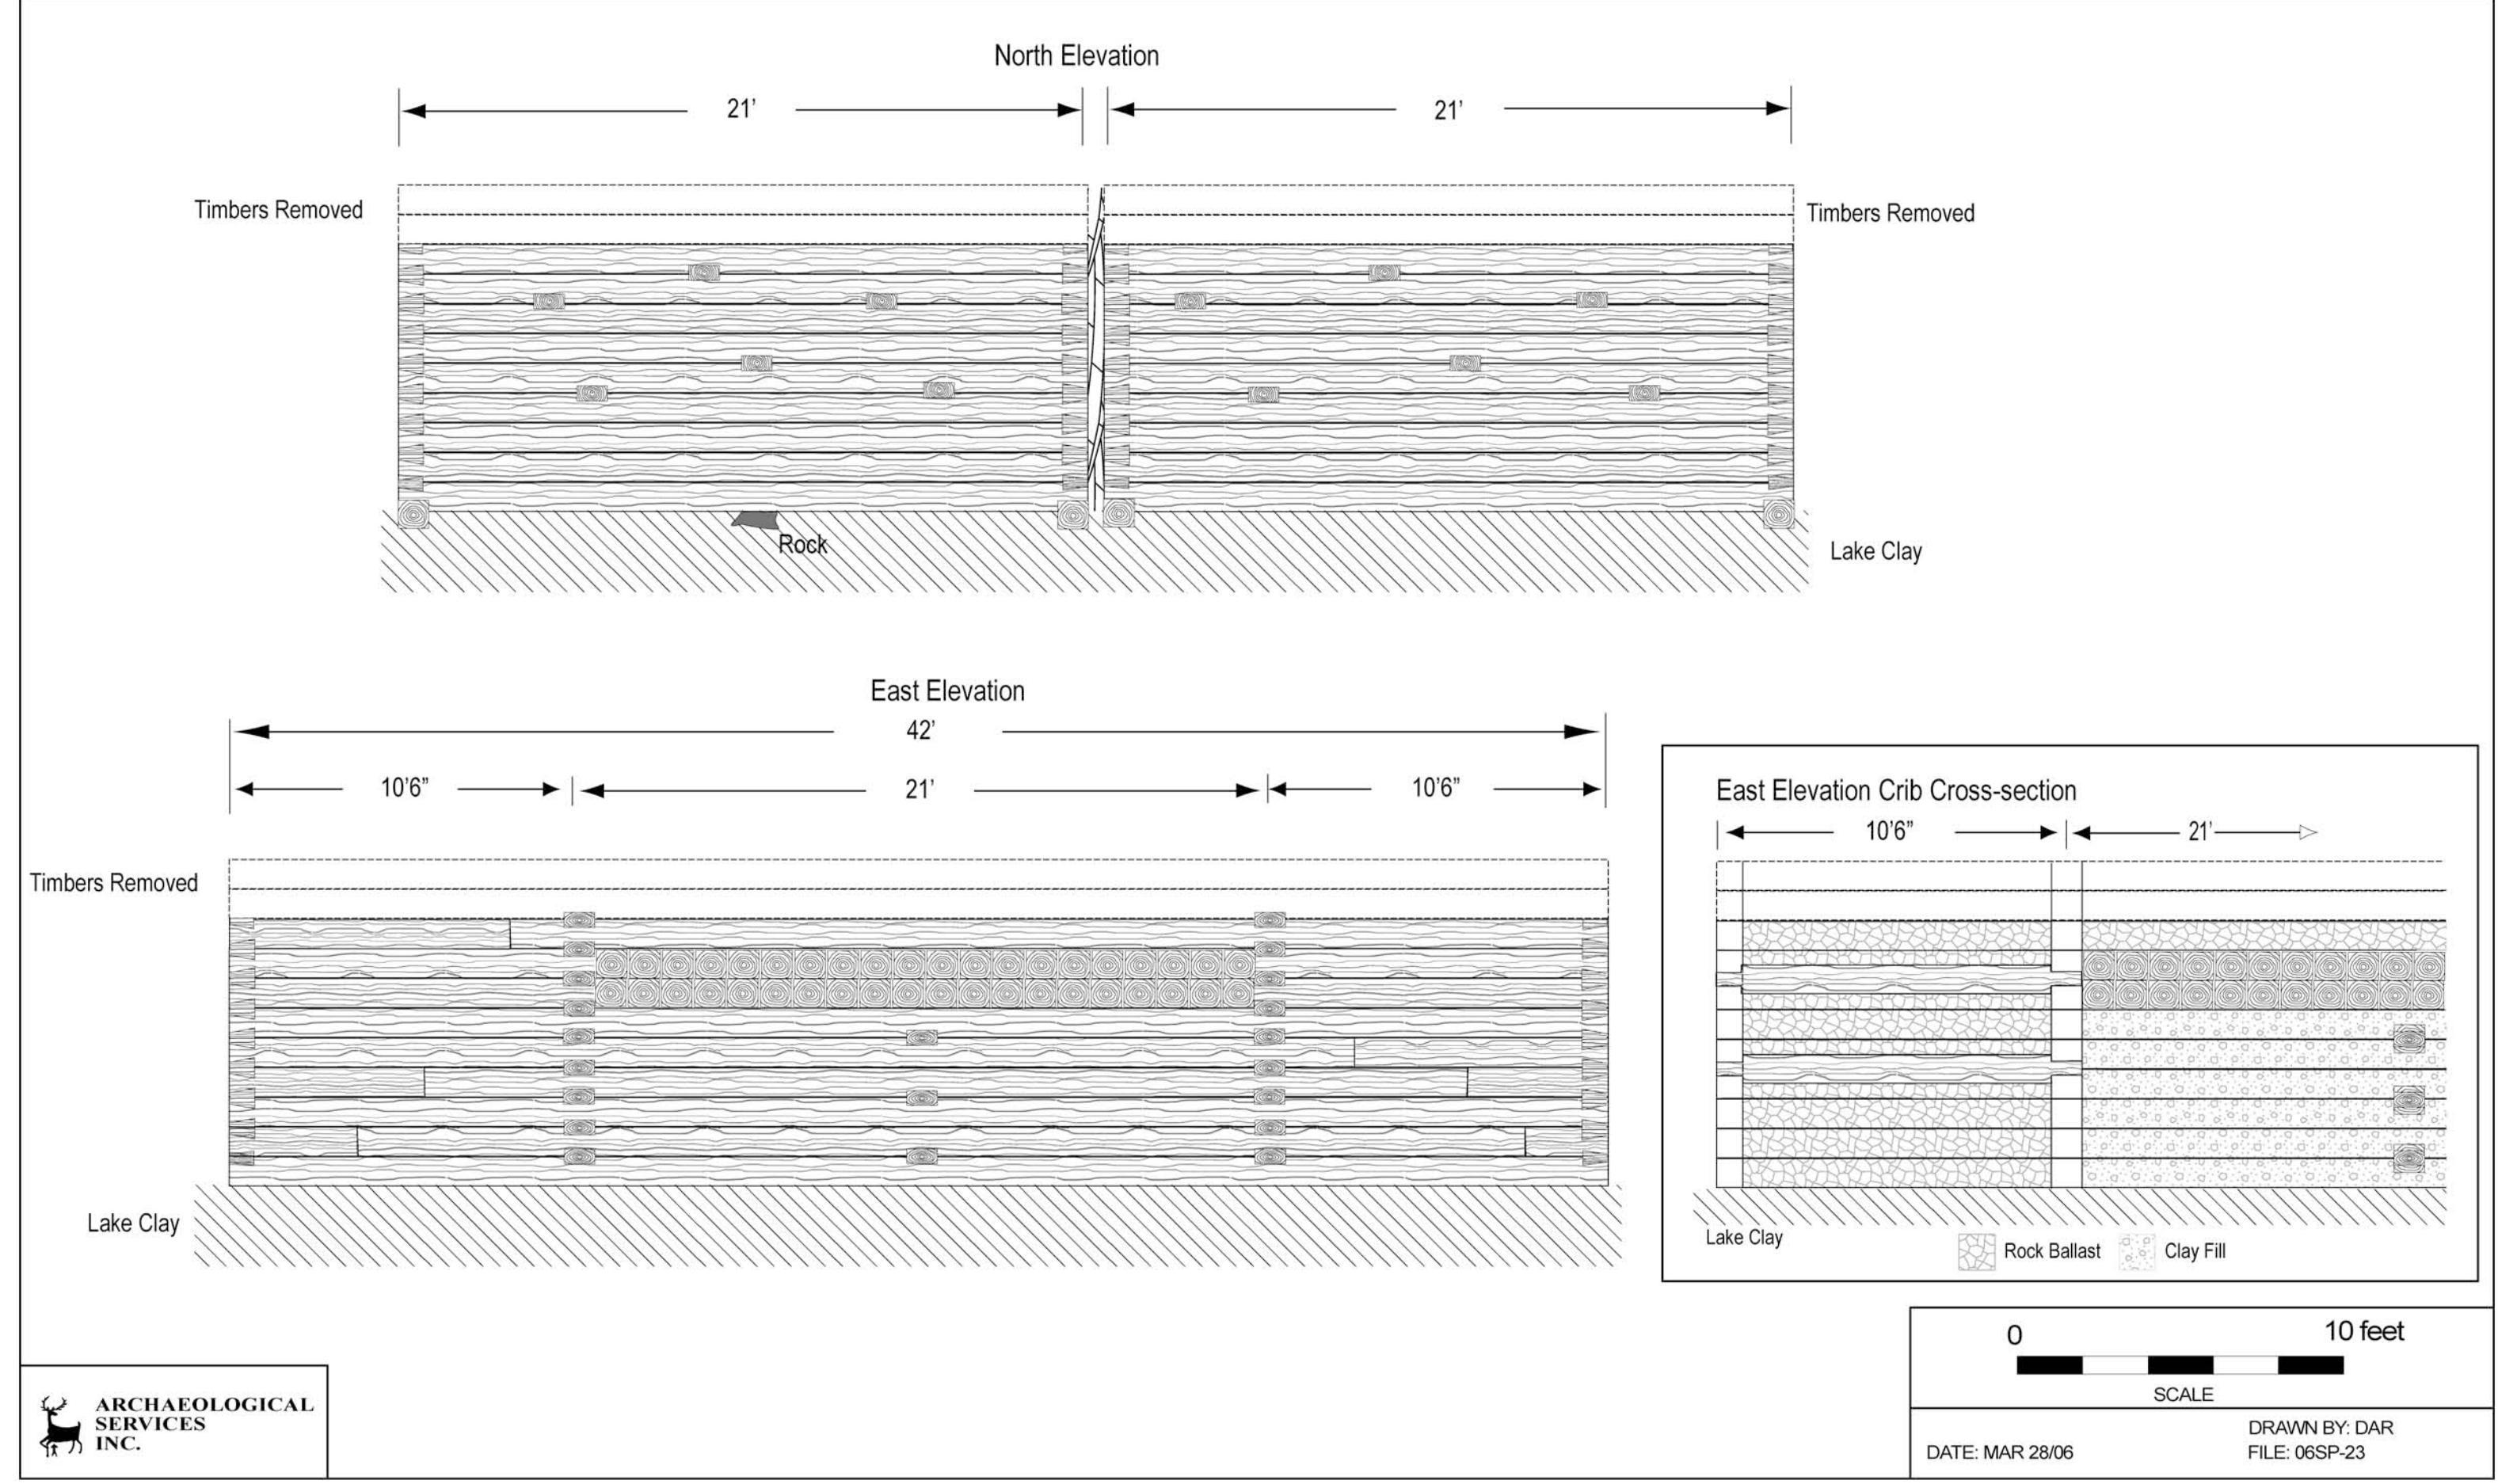
Figure 9: Composite Elevation views of the Queen's Wharf c. 1850 section, "Cribs 2-8", Block 7, Fort York Neighbourhood, City of Toronto

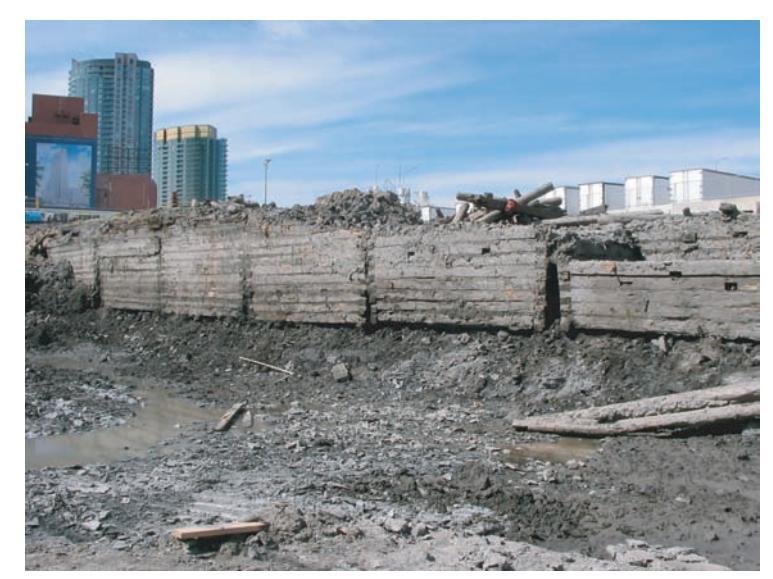
South face of the exposed 1850s crib work.

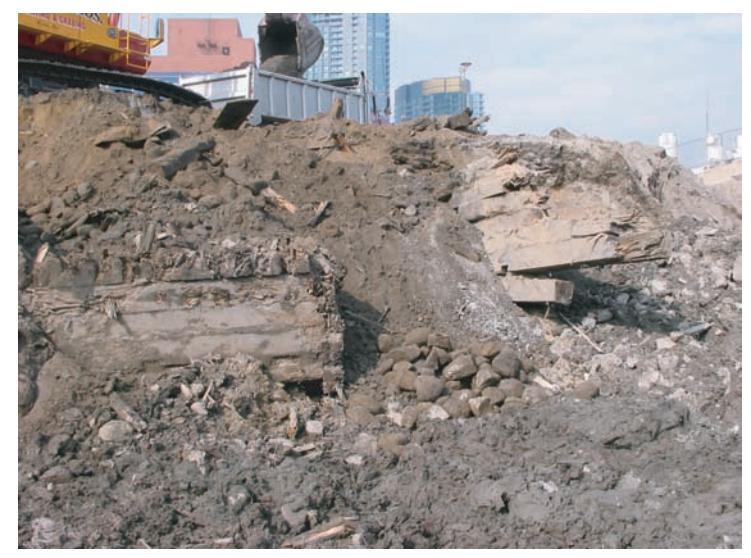
View of the partially exposed northwest end of the 1850s pierhead.

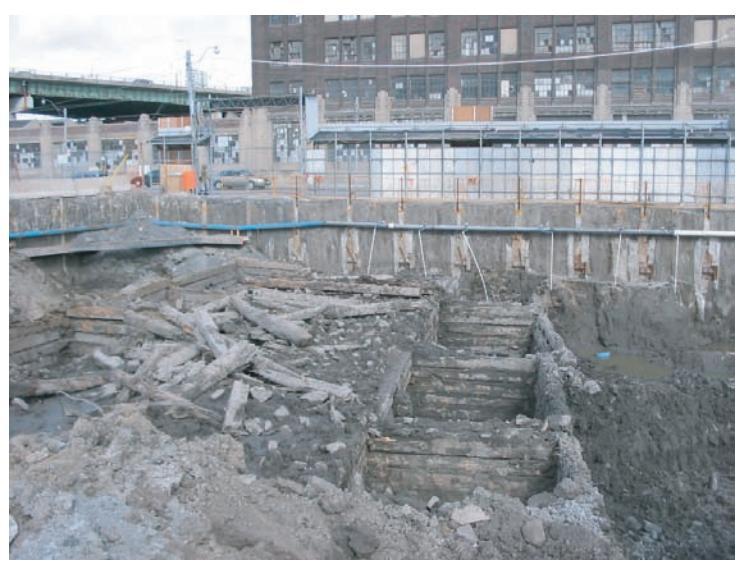
View east across the exposed 1850s crib work.

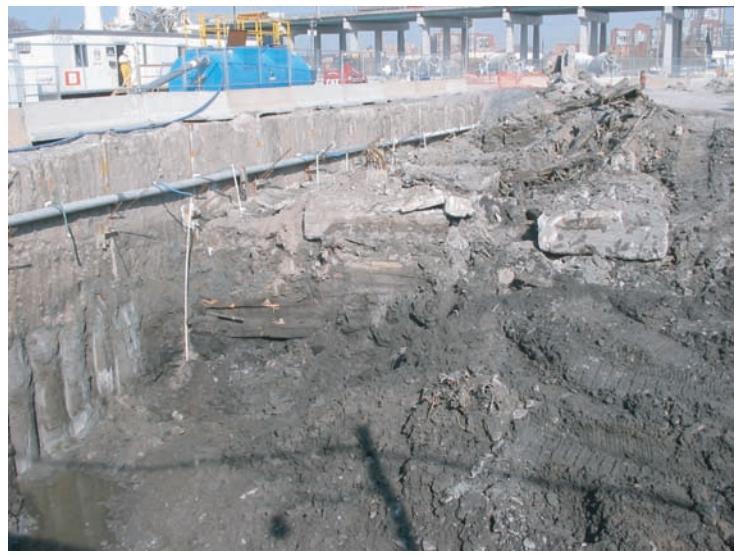
View of the partially exposed 1860s crib work.

Few remains of the 1860 extension of the pierhead could be discerned in large part because of the fact that this portion of the site was subsequently occupied by a building, most likely that first noted on the 1935 mapping that had been built using massive concrete footings and piles placed on top and through the

cribwork. Only four courses of timbers in the westernmost Crib 12 had survived this later occupation. Crib 11 survived to a height of 10 courses. The timbers that could be examined along the south face of the extension consisted of a mixture of 10", 11", and 12" square timbers. It is assumed that the cribs in this section were constructed to approximately the same dimensions as the 1850s structure, but this could not be confirmed. Again, the joinery was consistent with the earlier section.

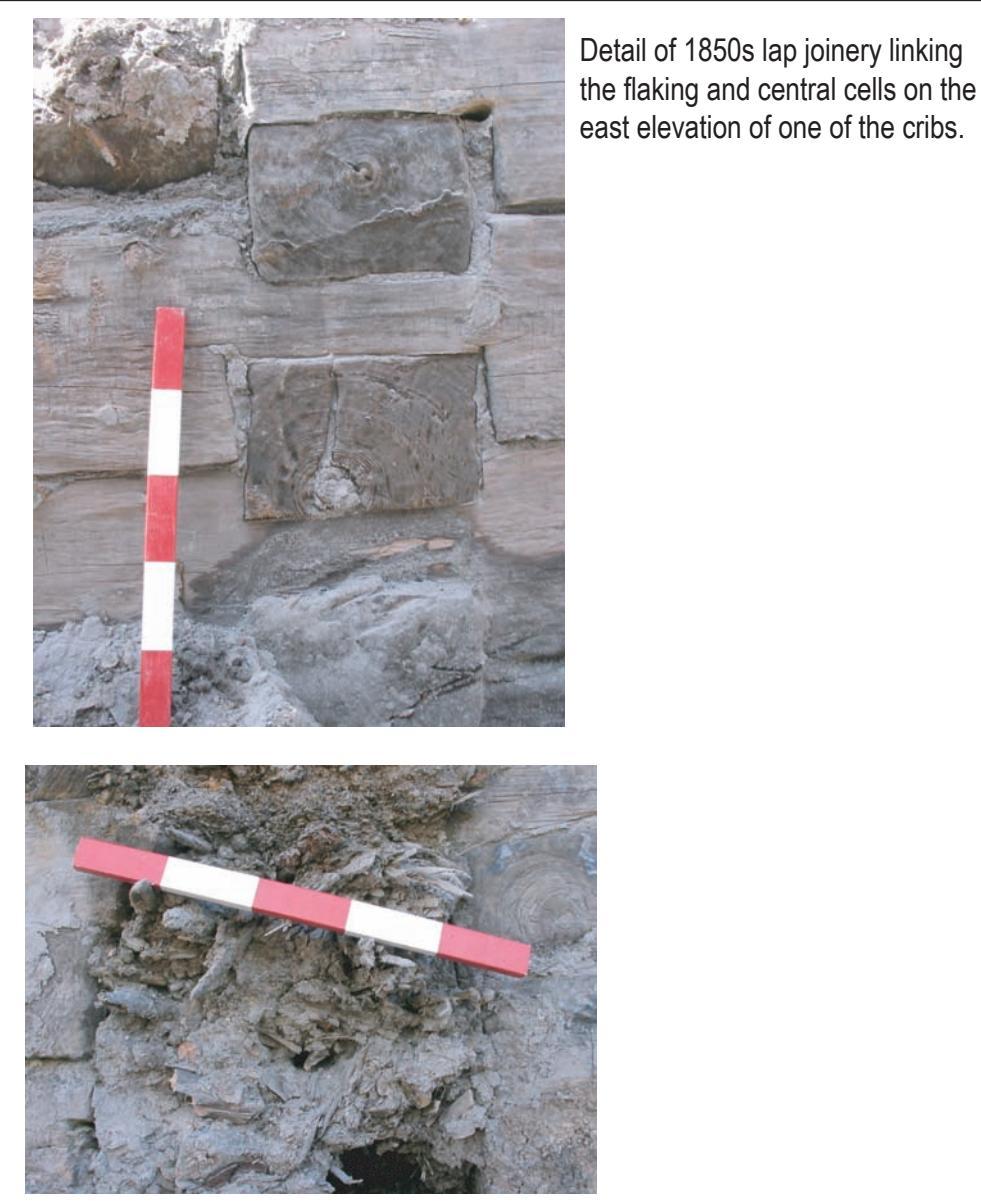
Roundwood and scrap fill between two 1850s cribs.

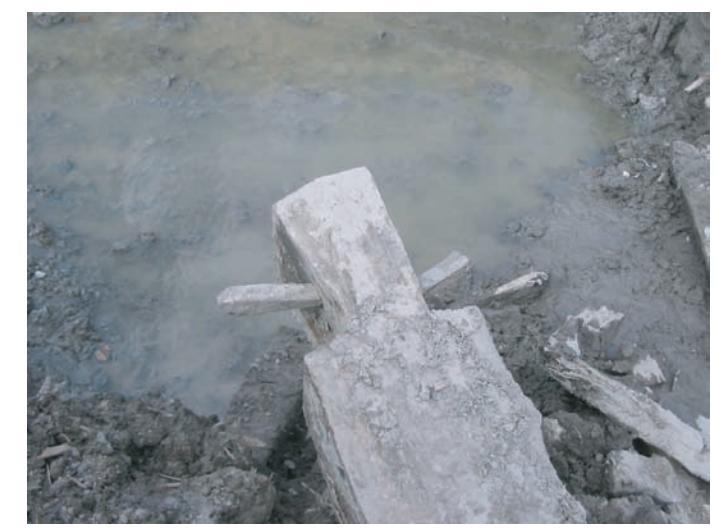
Treenailed dovetail on a timber from the 1850s crib work.

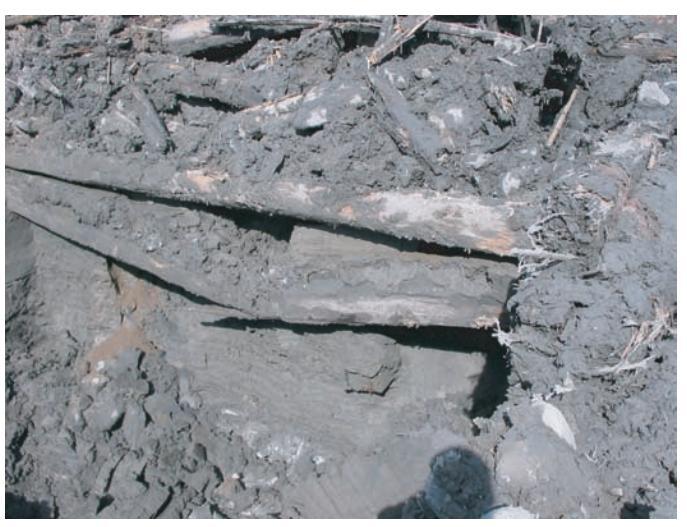
Clay beneath the "deck" in the central cell.

Despite being composed of three distinct cells, each crib was built as a fully integrated structure. Every third or fourth face timber along the east and west walls was a continuous 42' long beam. Where shorter lengths of timber were used along these faces, they were butt joined and anchored with 1" square iron rods three feet either side of the join. Although the butt joined timbers were of various lengths, they were arranged so that they occurred in a step pattern up the face of the wall, presumably for load-bearing purposes. The corners of the central cells were lap joined with 1' long  $1\frac{1}{2}$  to 2" square hardwood (likely white oak [cf. Bovey 1881]) treenails. Internal structural support within the central cells was provided by central 11" square tie back timbers that were mortised into the east and west face walls between the first and second, third and fourth and fifth and sixth courses. Another unusual feature of the central cribs was that at the level of the seventh and eighth courses, a "deck" comprised of two layers of 11" square timbers had been laid east west across the crib. These timbers were not, however, fixed into the structure with any sort of hardware or joinery. Only the presence of additional courses of face timbers above them served to anchor them in place. The fill below this deck consisted of homogeneous fine bluish-grey silty lake clay. Rock ballast lay atop the "deck." The function of this "deck" is uncertain. It likely lay below the railway bed known to have been on the surface of the superstructure, but it would not have served any loadbearing purpose, as the beams were oriented parallel rather than perpendicular to the line of the tracks. It is possible, in the absence of crib flooring, that this deck is related to the original process of sinking the

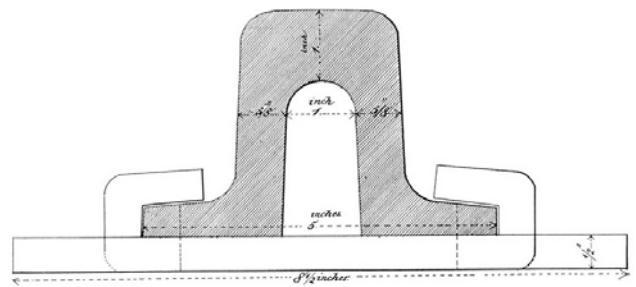
Two sections of rail were observed among stock piles of later scrap metal collected from the site during the initial excavations. One of these (Figure 12) was a piece of 63 pound Grand Trunk Railway U-rail that dates to the 1850s (Andreae 1997:24). The other was a section of a 56 pound T-rail that likely dates to the 1860s (C. Andreae, personal communication, 2006).
